# Blackout in Spain and Portugal on 28 April 2025

Expert Panel Factual Report >> 27 October 2025 >> ESIG workshop

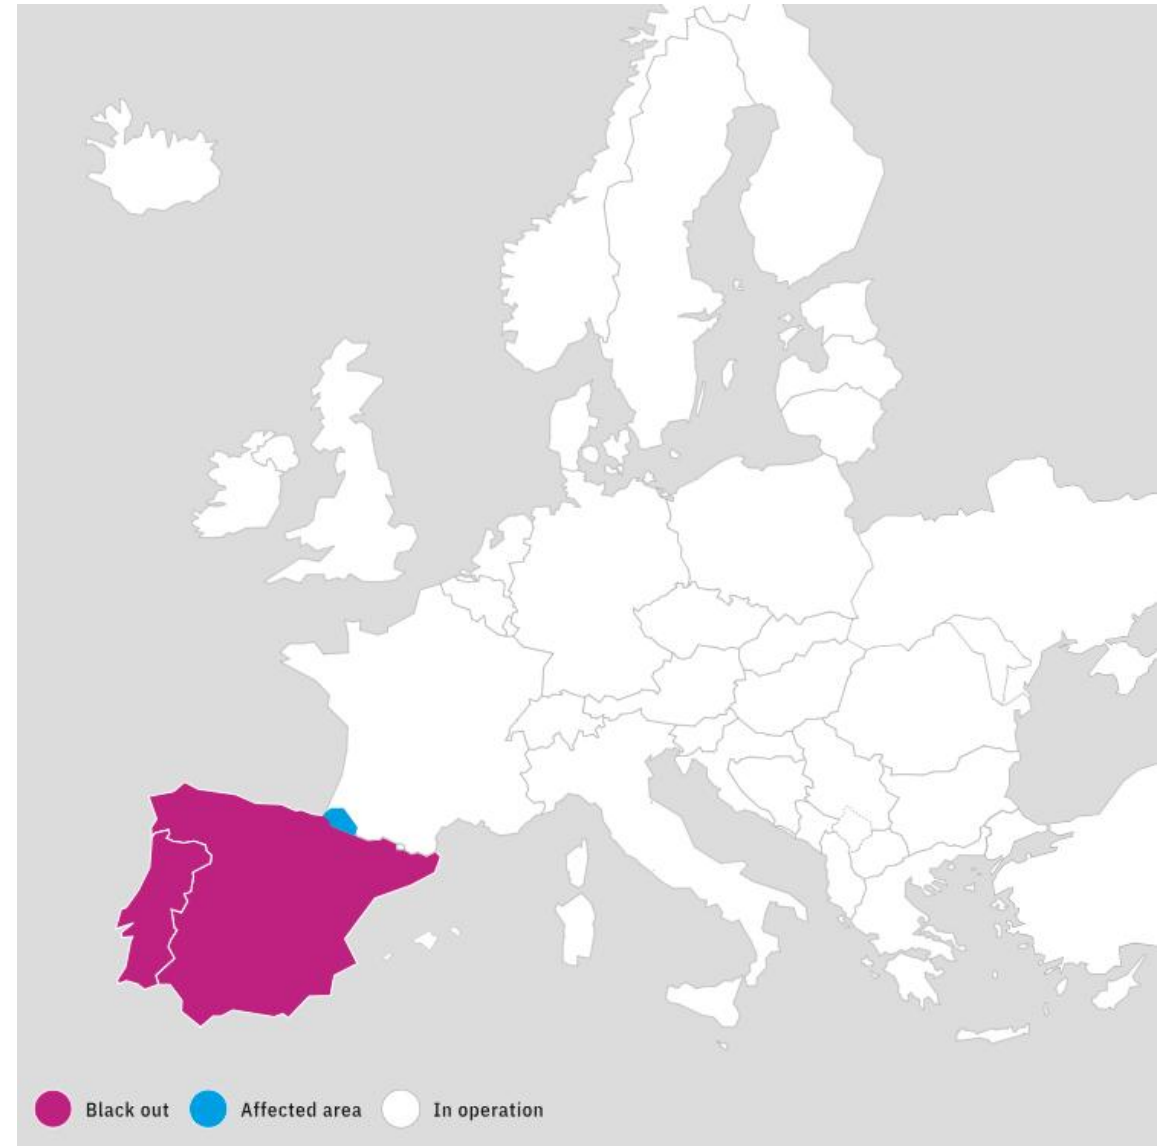
- On 28 April 2025, at 12:33 CEST, continental Spain and Portugal suffered a blackout.
- A small area in the South of France (at the border with Spain) was also affected during a very short period of time.
- The rest of the European power system did not experience any disturbance resulting from the incident.
- **This was the most severe blackout incident on the European power system in over 20 years, and the first ever of its kind (overvoltage).**
- It had major repercussions for citizens and society.

**Figure:** Geographic area affected by the 28 April 2025 incident

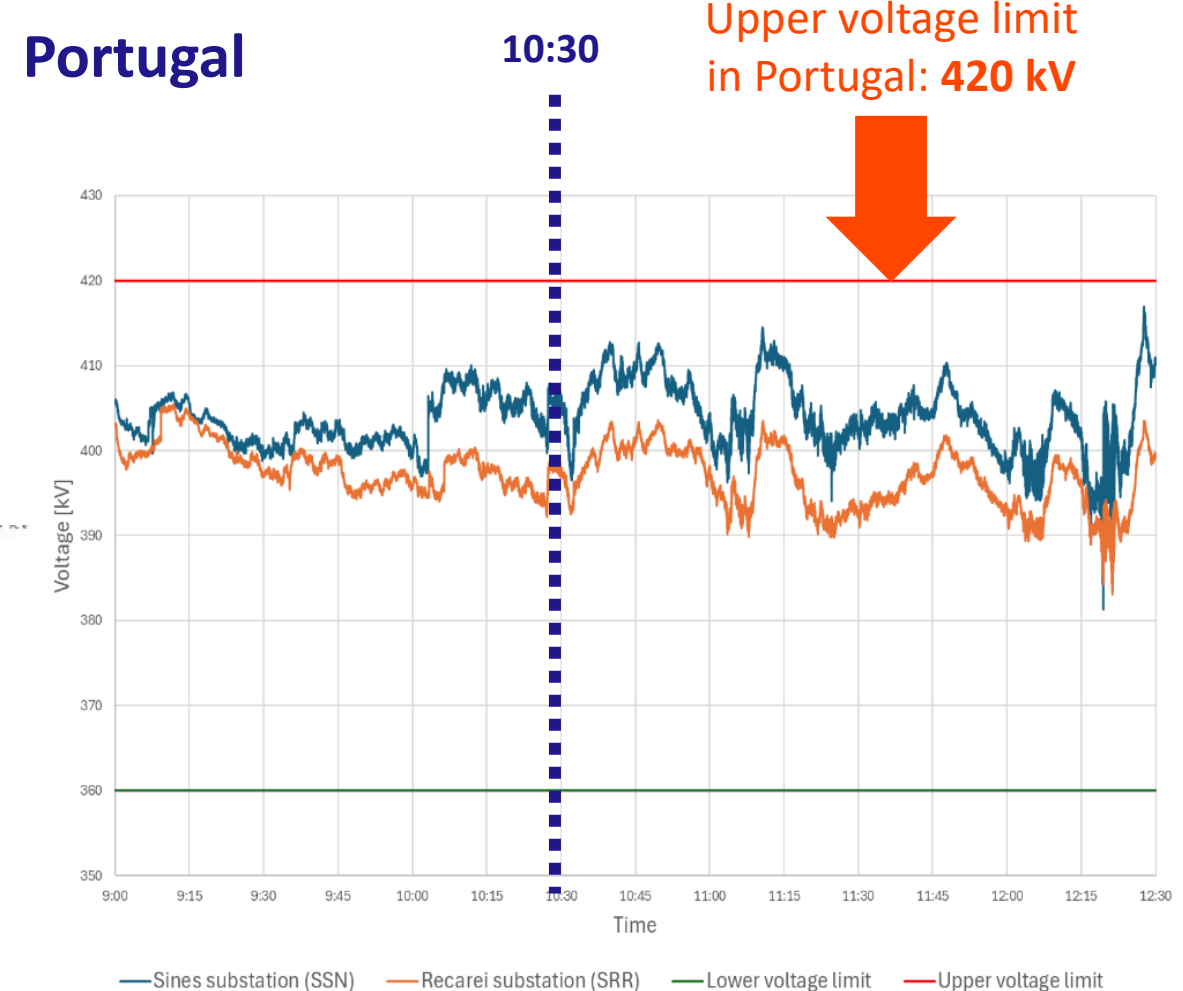
\* These values may occur eventually at the 400 kV level (confirmed by CNMC, Spanish regulator)

First significant variations of the voltage from 10:30 CEST

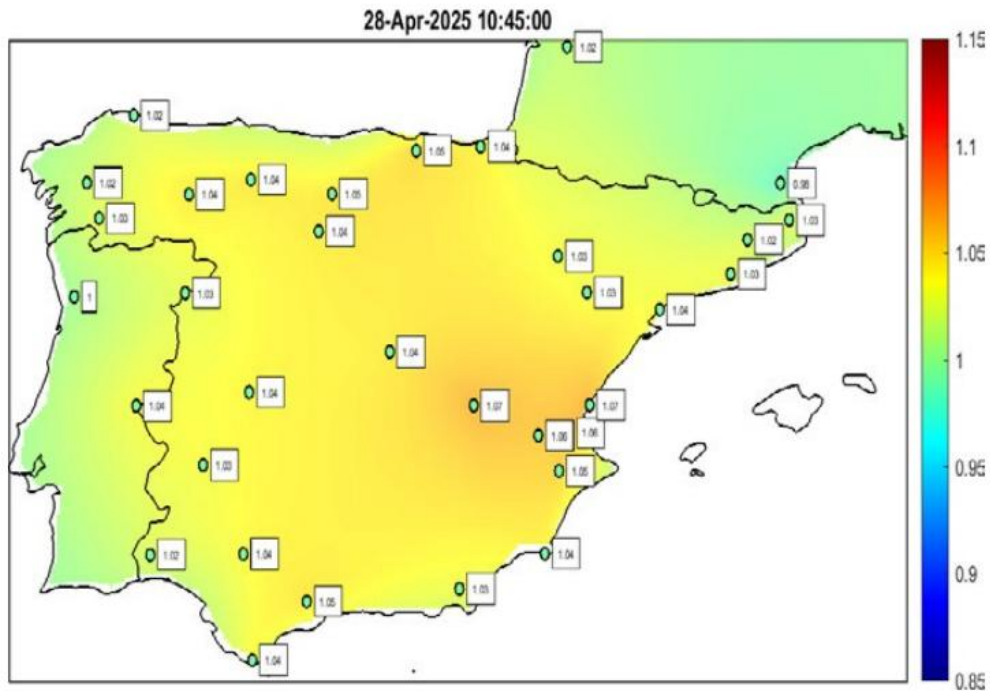
**Figure:** Voltage heatmap at 10:45

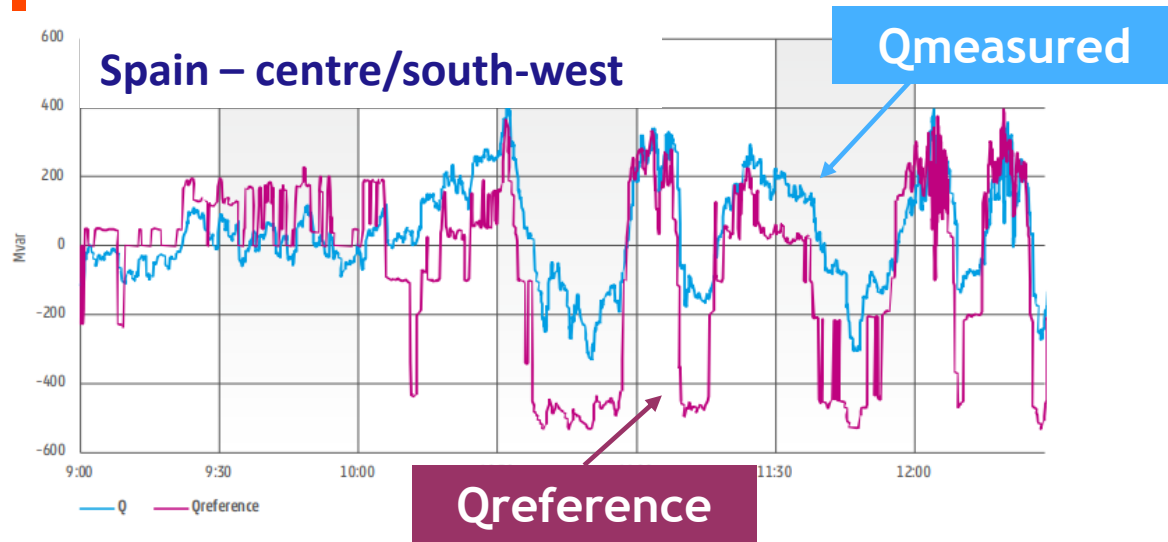
Figure: Reactive power provided (Q) and the reference reactive power (Qref) aggregated for conventional generation units larger than 100 MW of power installed capacity in the centre/south-west area of Spain

- A difference was observed between reference and measured values (applicable only to conventional generators - RES generators were required to provide the service via fixed power factor).
- As explained by the Spanish regulator, Qreference is the reactive power control service to be provided by generators, without prejudice that compliance allows a time margin of 25% outside that area.

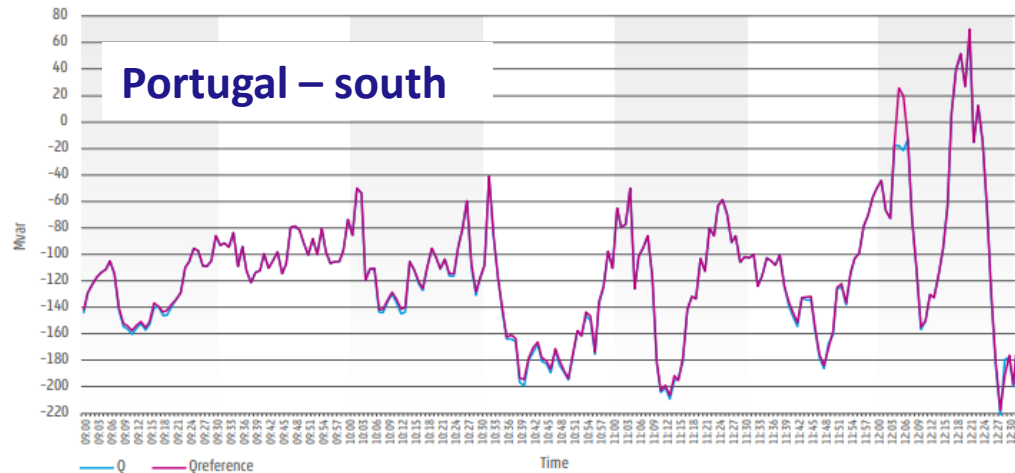
Figure: Provided reactive power (Q) and reference reactive power (Qreference) for generating relevant power plants with more than 100 MW of power installed capacity in the south area of Portugal (REN's SCADA measurements)

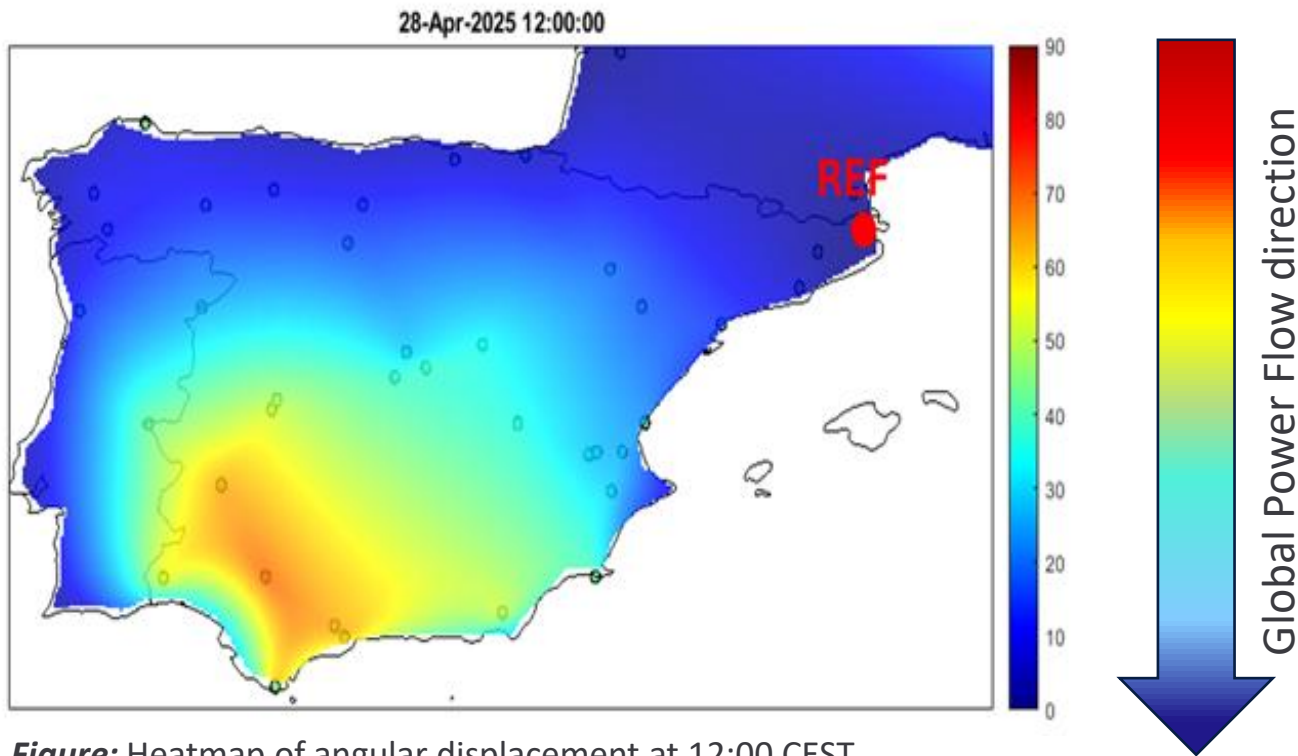
**Figure:** Heatmap of angular displacement at 12:00 CEST

- Heterogeneous distribution of generation in Spain before the incident
- Southwest region is “pushing” active power in the surrounding areas

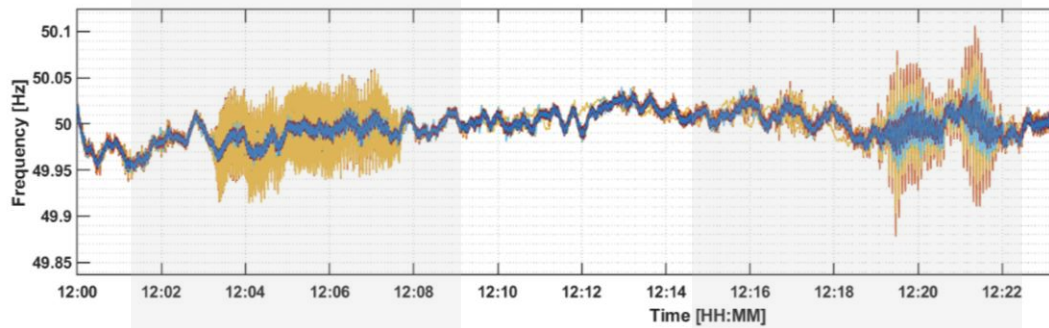
*Local oscillation  
with 0,63 Hz*

- Lines were switched on to decrease the system impedance.
- Fixed power operation mode was set up on the HVDC link between Spain and France.
- The flow between Spain and France was reduced.

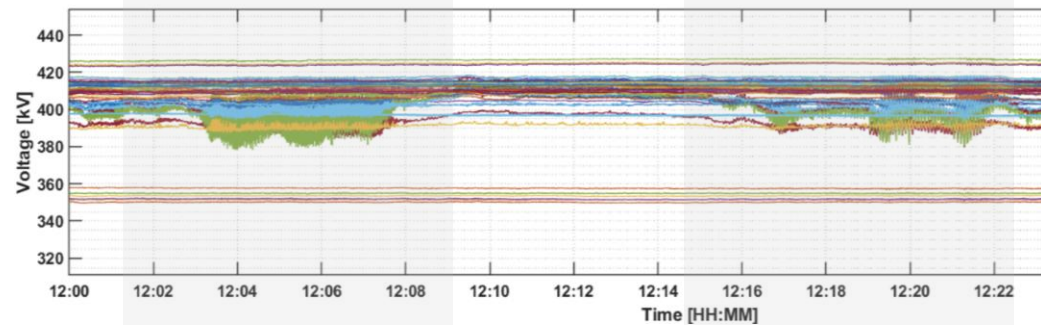
*Inter-area  
oscillation with  
0,21 Hz*

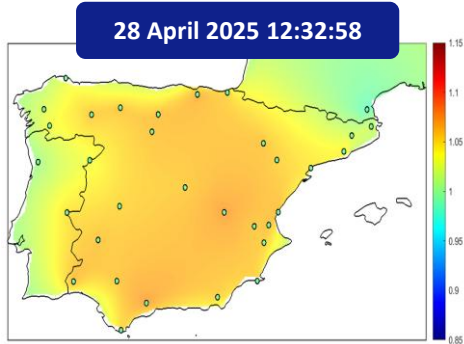
**First event:** Events started milliseconds after 12:32:57 CEST with the tripping of a generation transformer in the region of Granada, due to the activation of an overvoltage protection.

The transformer was injecting 355 MW into the grid at this time and there were 417.9 kV in the 400 kV transmission side.

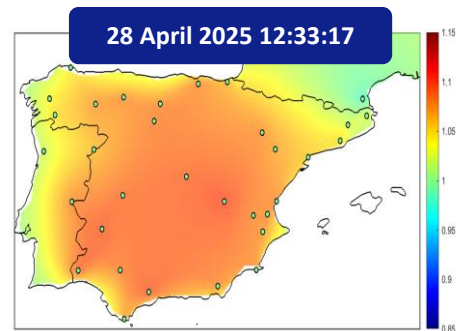
**Second event:** Included trips of PV and thermo-solar facilities connected to two 400 kV transmission substations, in Badajoz, with a total interrupted injection of around 725 MW. The last SCADA voltage reading was 434.0kV at evacuation bay, 430.5kV and 429.9kV at busbars.

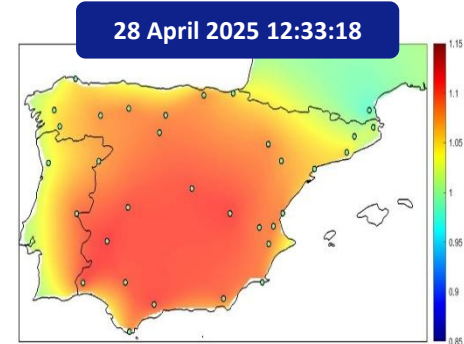
**Third event:** Included several trips between 12:33:17 CEST and 12:33:18 CEST, which led to disconnection of wind and solar generation in Segovia, Huelva, Badajoz, Sevilla and Caceres for a total of approximately 930 MW (or more than 1,100 MW, as implied by the variation of frequency).

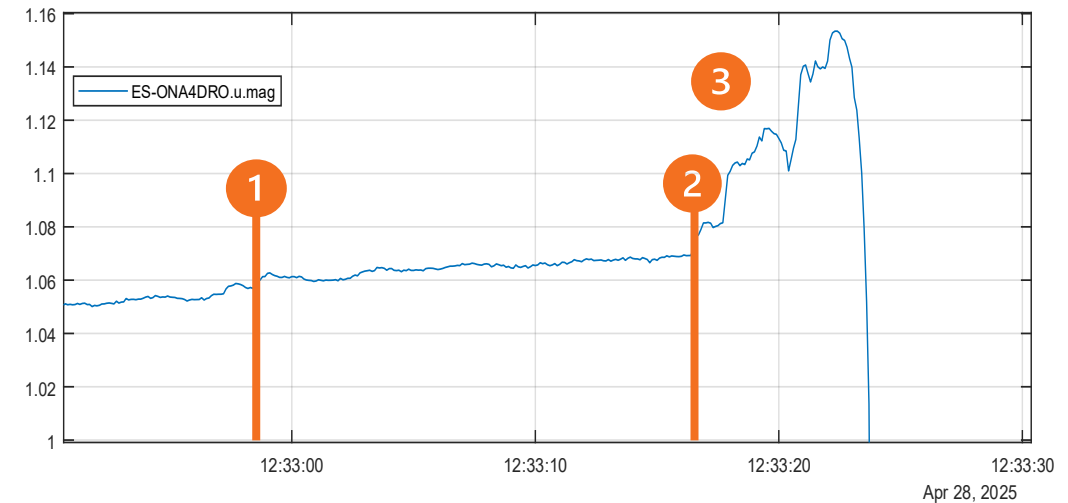
**Figure:** Evolution of voltage in the node Carmona during tripping events. Voltages in nodes closest to the three events are not shown

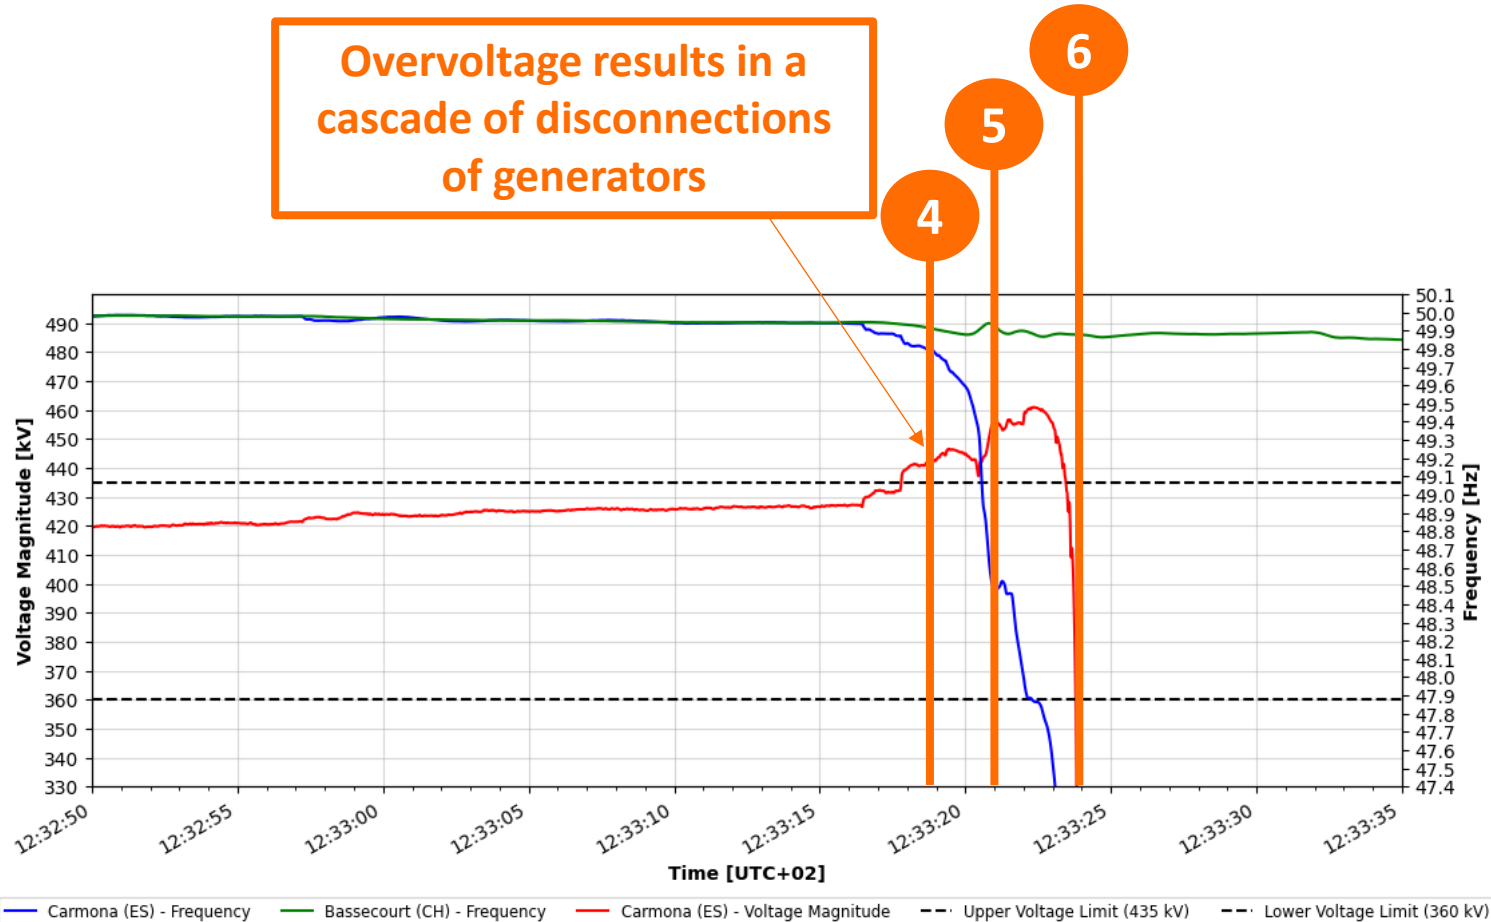
Overvoltage results in a cascade of disconnections of generators

- Decrease of frequency on Iberian Peninsula and loss of synchronism with rest of Continental Europe
- System Defence Plans (automatic load shedding) were activated in Spain and Portugal but unable to stop the blackout due to its overvoltage nature

- Disconnection of all AC lines from Spain to Morocco and France

- The HVDC stops exporting power from Spain to France

**Figure:** Evolution of the frequency and the voltage in the substation of Carmona (Spain) and of the frequency in the Bassencourt, Switzerland) during the incident (sources: Red Electrica, Swissgrid).

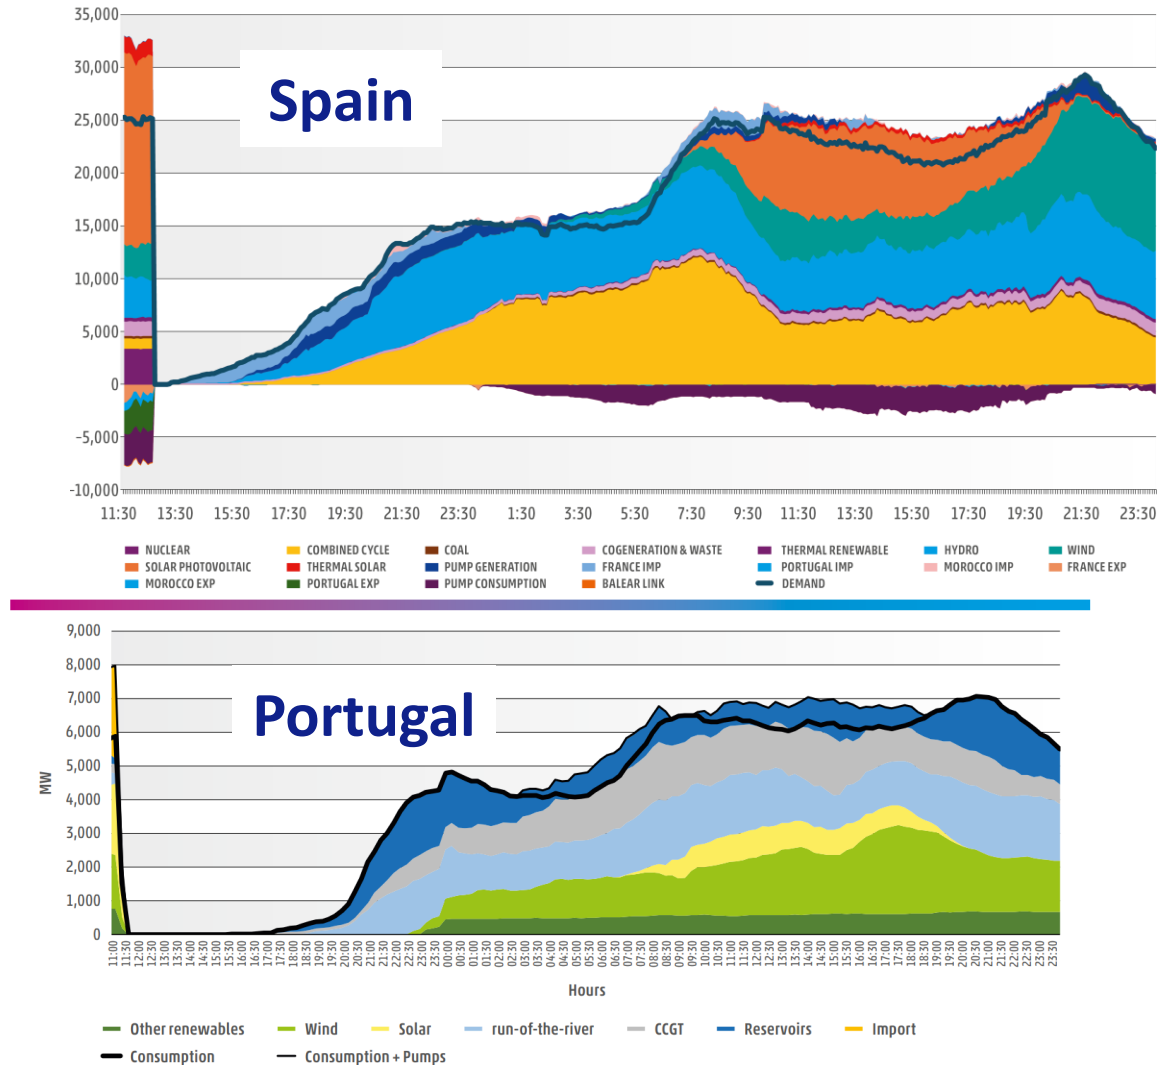
Figures: Evolution of generation and load until end of 29 April

Figure 4-29: Evolution of generation and load of the Portuguese system until the end of 29 April - REN

- The power system restoration of the electrical system started with the support of the **interconnections of France and Morocco** to the Spanish system, and later via the complementary activation of black-start processes in certain power plants.
- In the Portuguese system the restoration started by black-start processes in two power plants and later supported by the interconnections of Spain.
