Chilean Grid Blackout of February 2025: Causes and Lessons

ESIG 2025 Fall Technical Workshop

Coordinador Eléctrico Nacional (CEN) - Chile

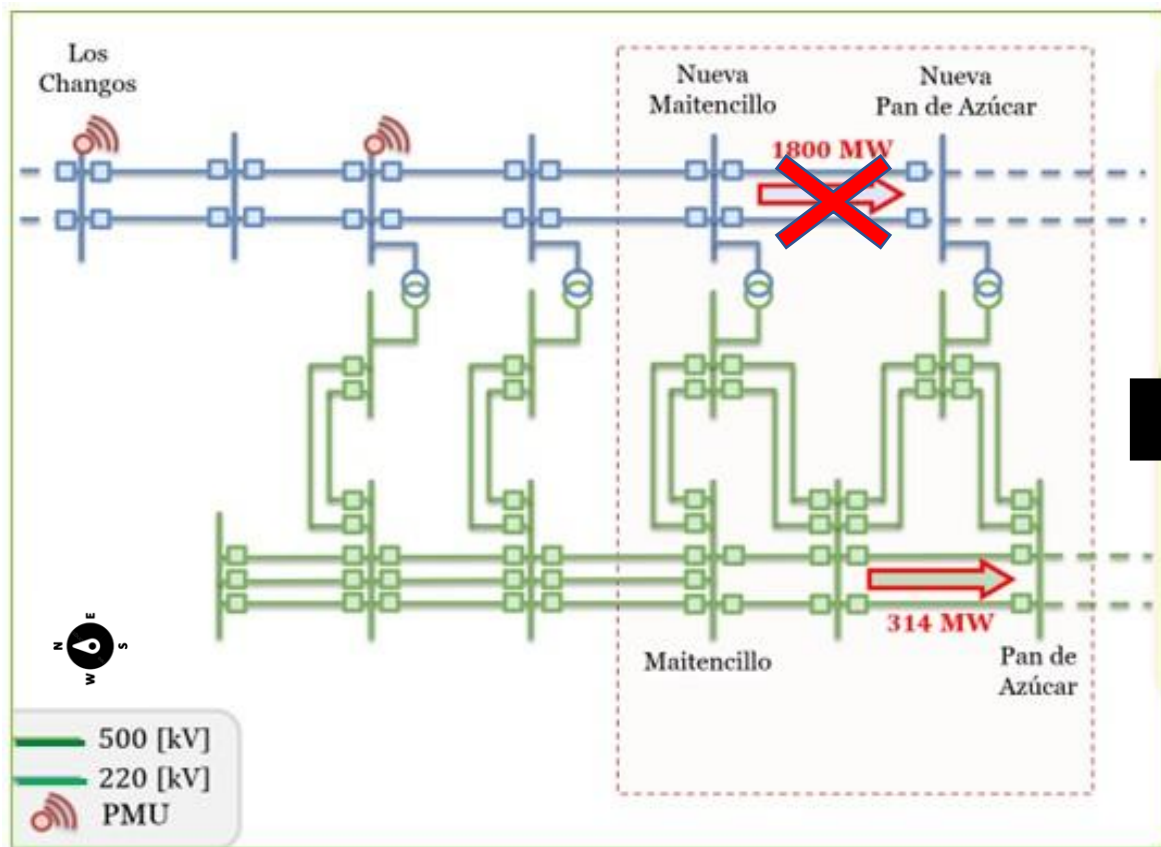
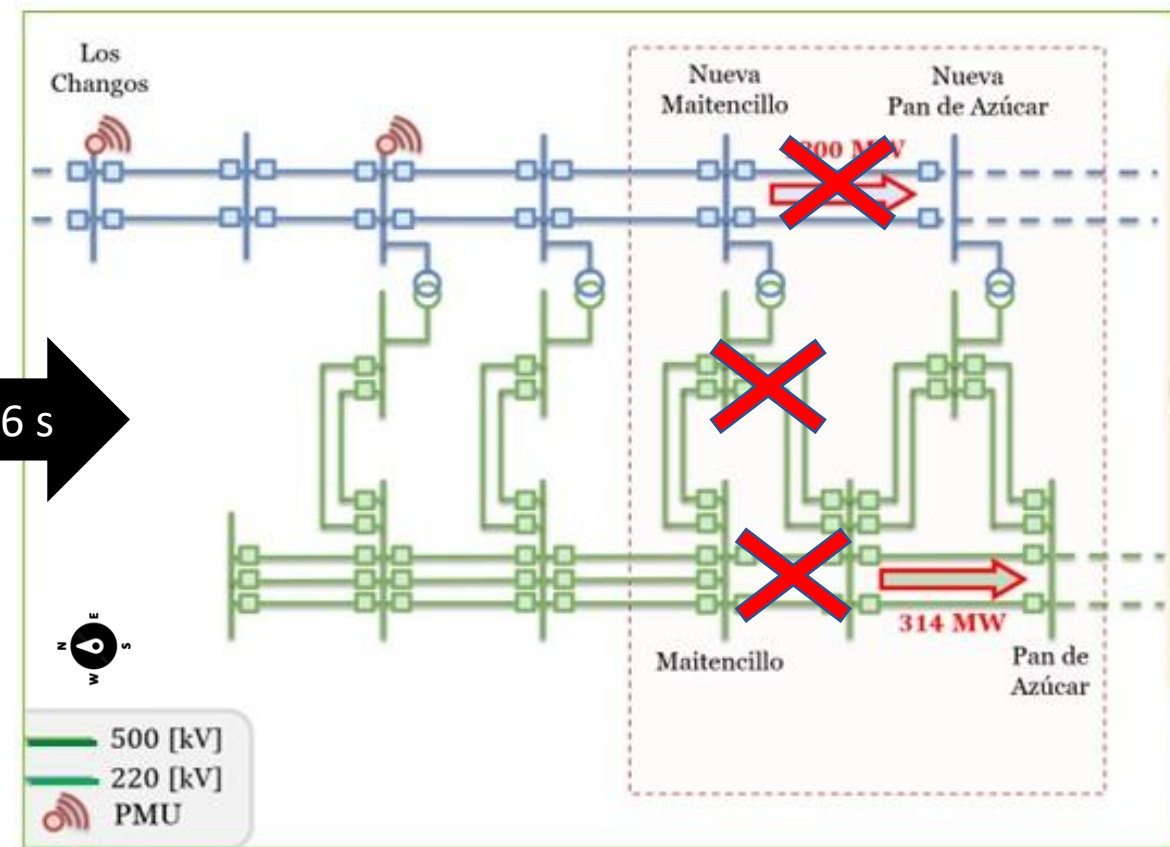
After 1.6 s

- Manual intervention to resync the telecom module of 87L protection caused the **unexpected trip of the two circuits** in one of the main 500 kV lines.
- The system remained interconnected through a weak 220kV link, and **after 1.6s, it separated into two islands**: North (30%) and Center-South (70%).

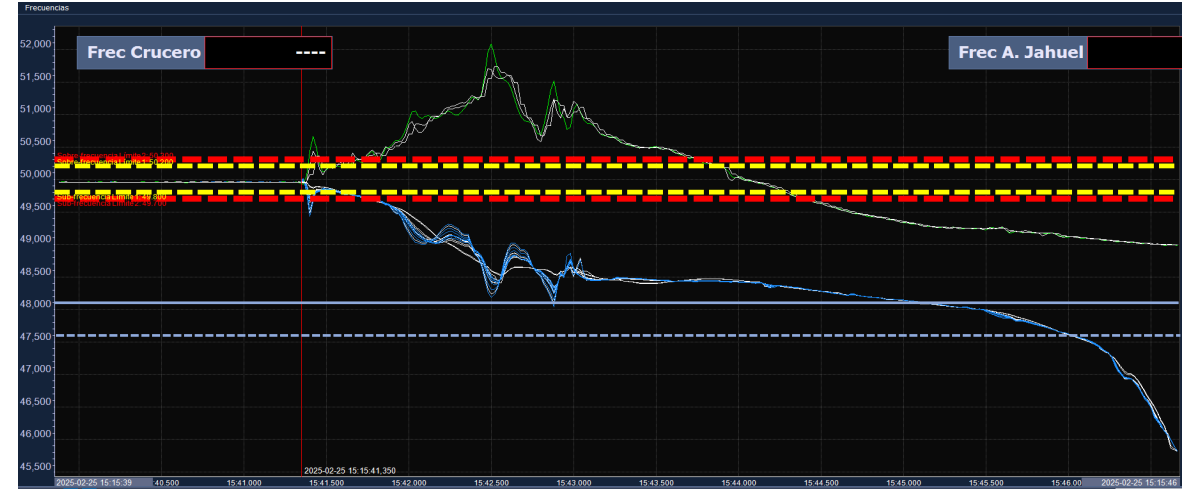
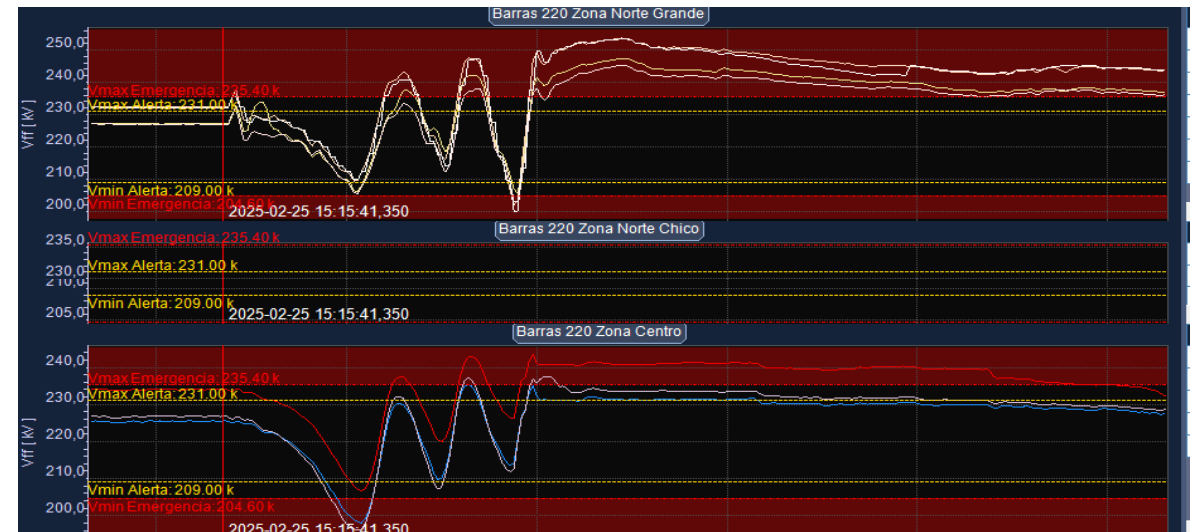
Initial Impact

- 1.6 s delay triggered **severe power and voltage oscillations**, tripping OFLS and UFLS resources.

Northern Island

- **Remained stable for ~4 min**, then collapsed due to low frequency.
- Generators tripped from overvoltages before and after separation.

Central-South Island

- **Collapsed in ~4 s** from low frequency, following multiple generator trips and partial UFLS (DER) failure.

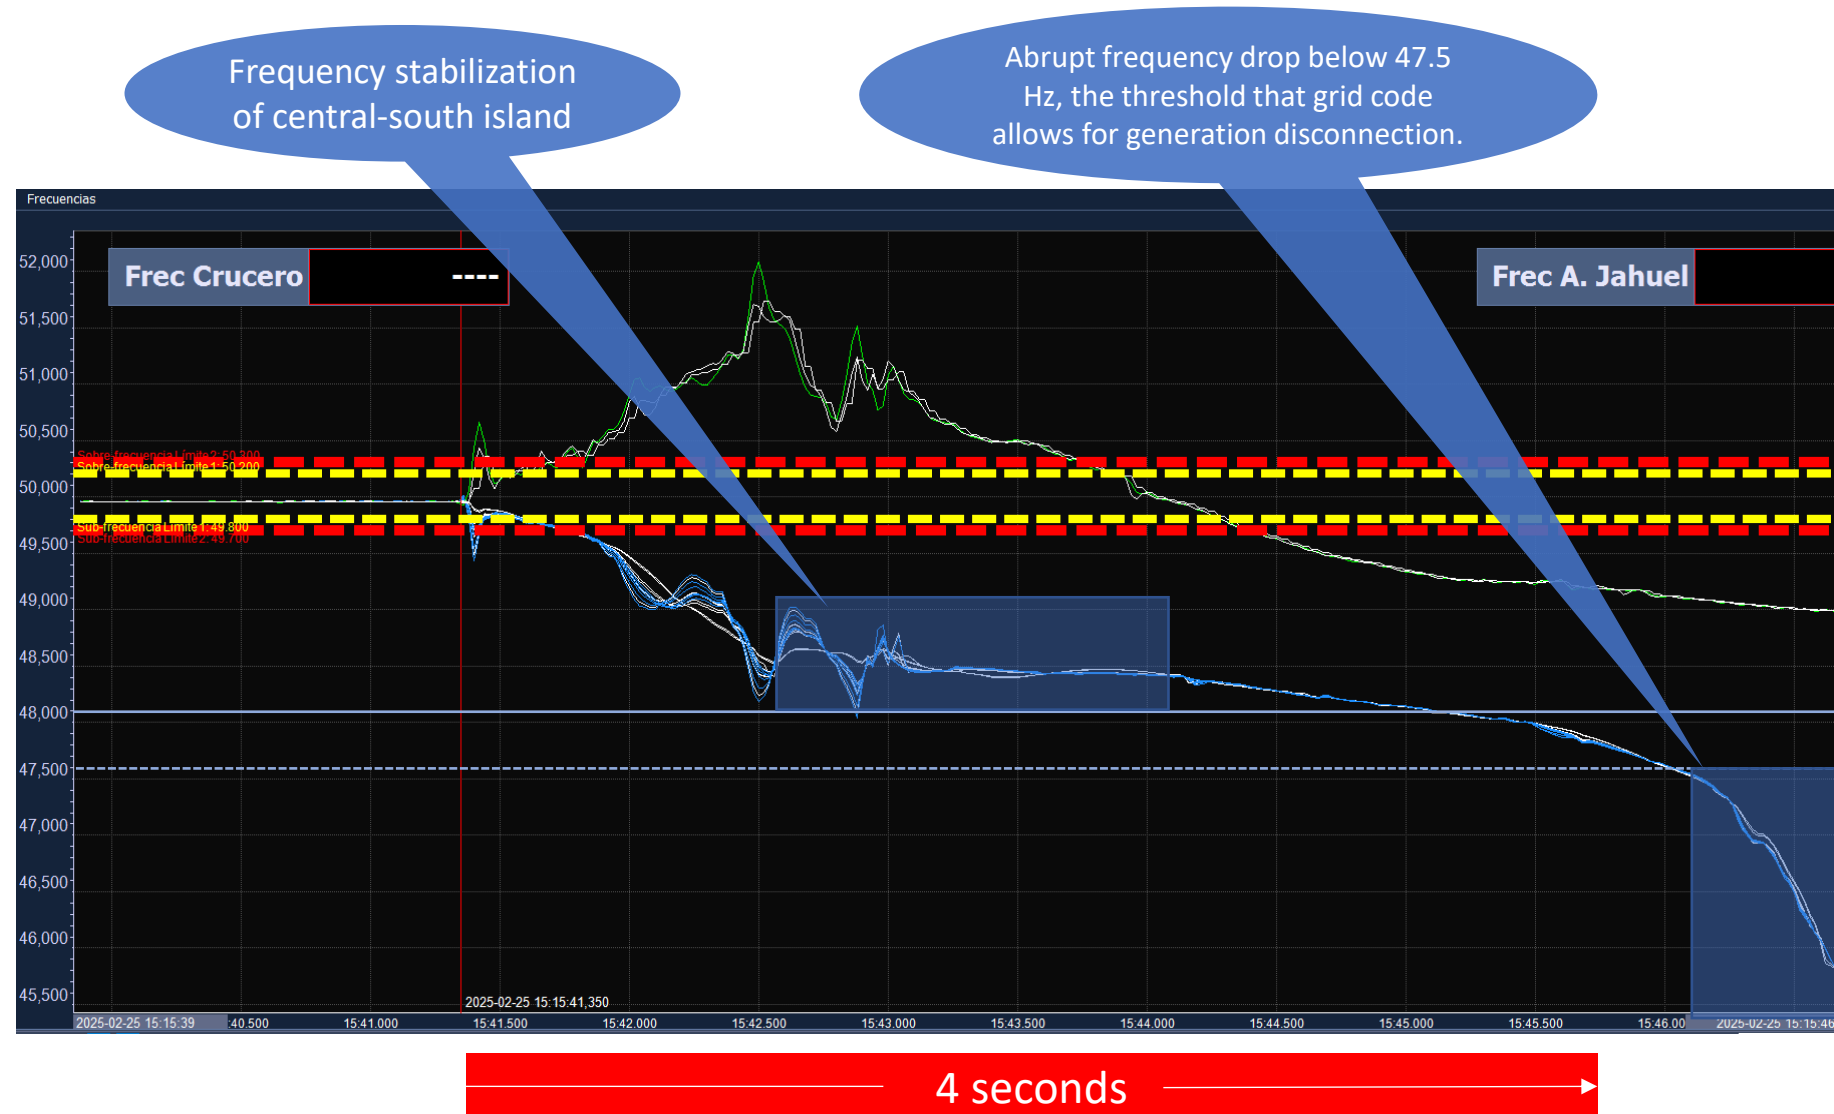
Frequency evolution Center-South Island

- Rapid frequency decline driven by poor contingency response and generation behavior.
- Temporary stabilization at 48.5 Hz, then gradual fall to 47.5 Hz (≈ -0.3 Hz/s).
- Crossing 47.5 Hz triggered additional trips, leading to total loss of supply

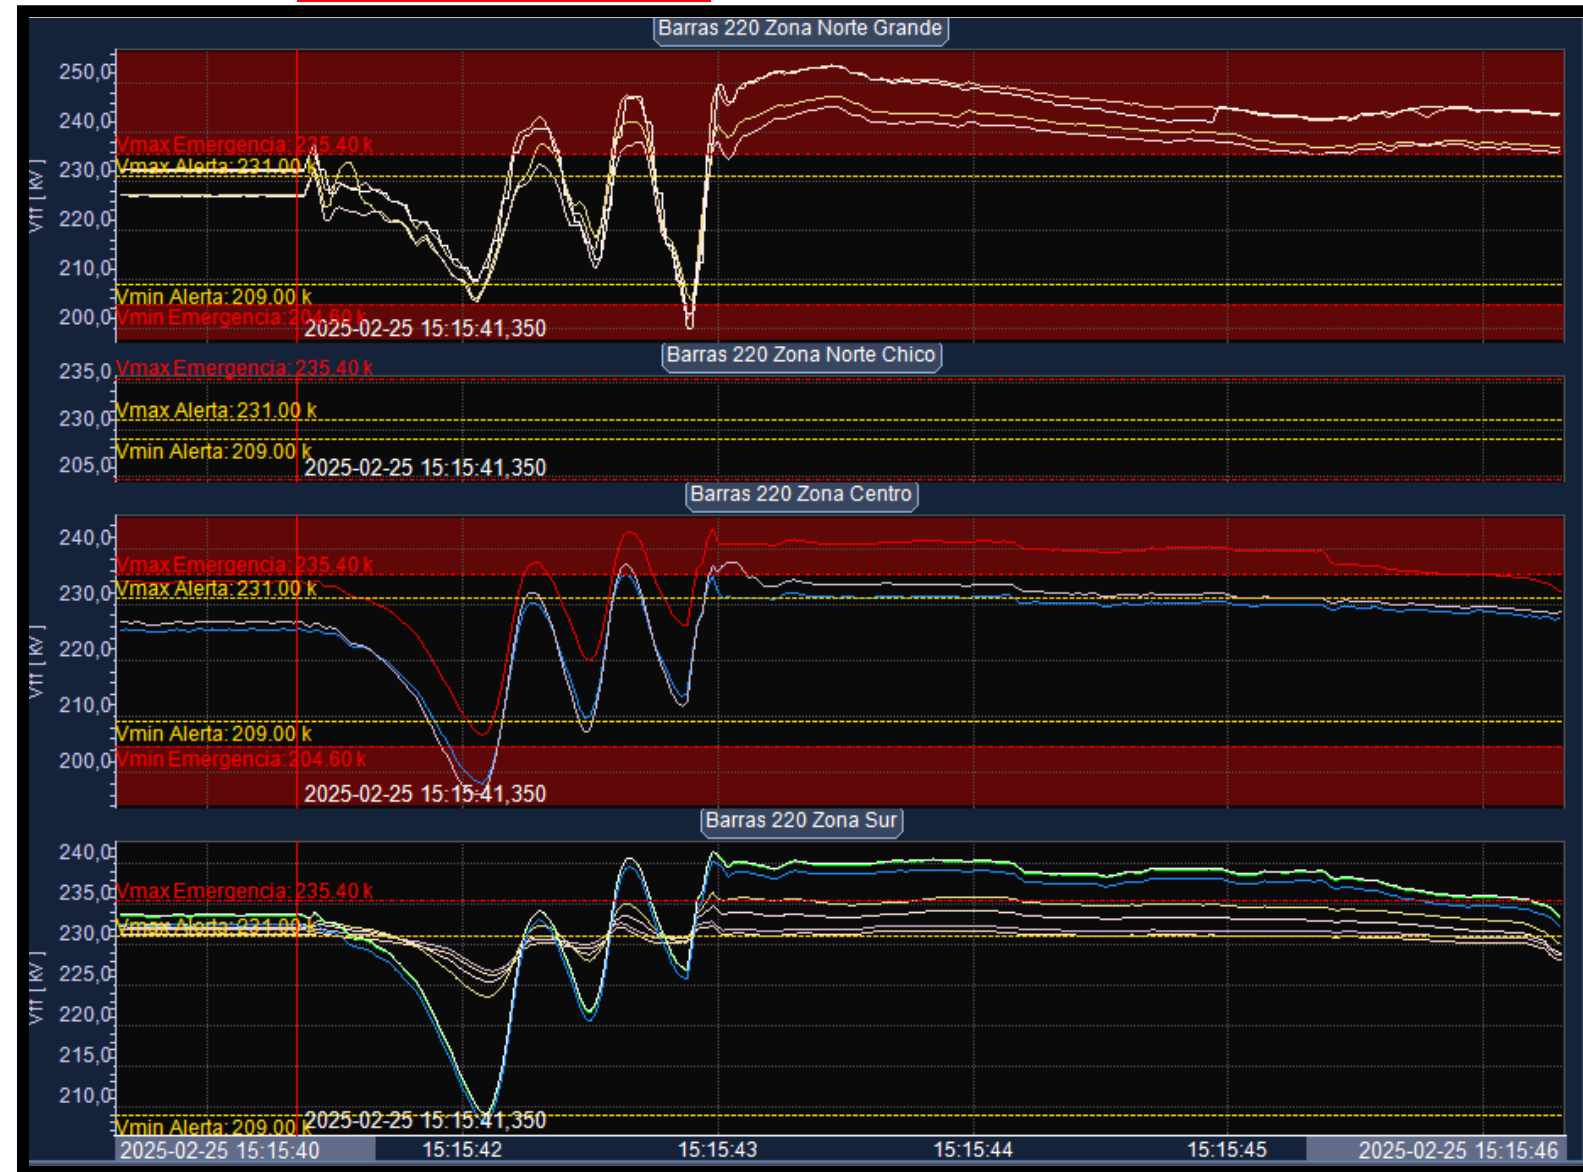
Voltage evolution

Northern Zone

- Voltage rise caused by lack of voltage control in VRE plants and loss of reactive compensation.
- Rapid increase observed within **1.6 s**, remaining above alert thresholds.

Central-South Zone

- Moderate voltage rise following system separation.
- Increase less pronounced but persistent during the event.

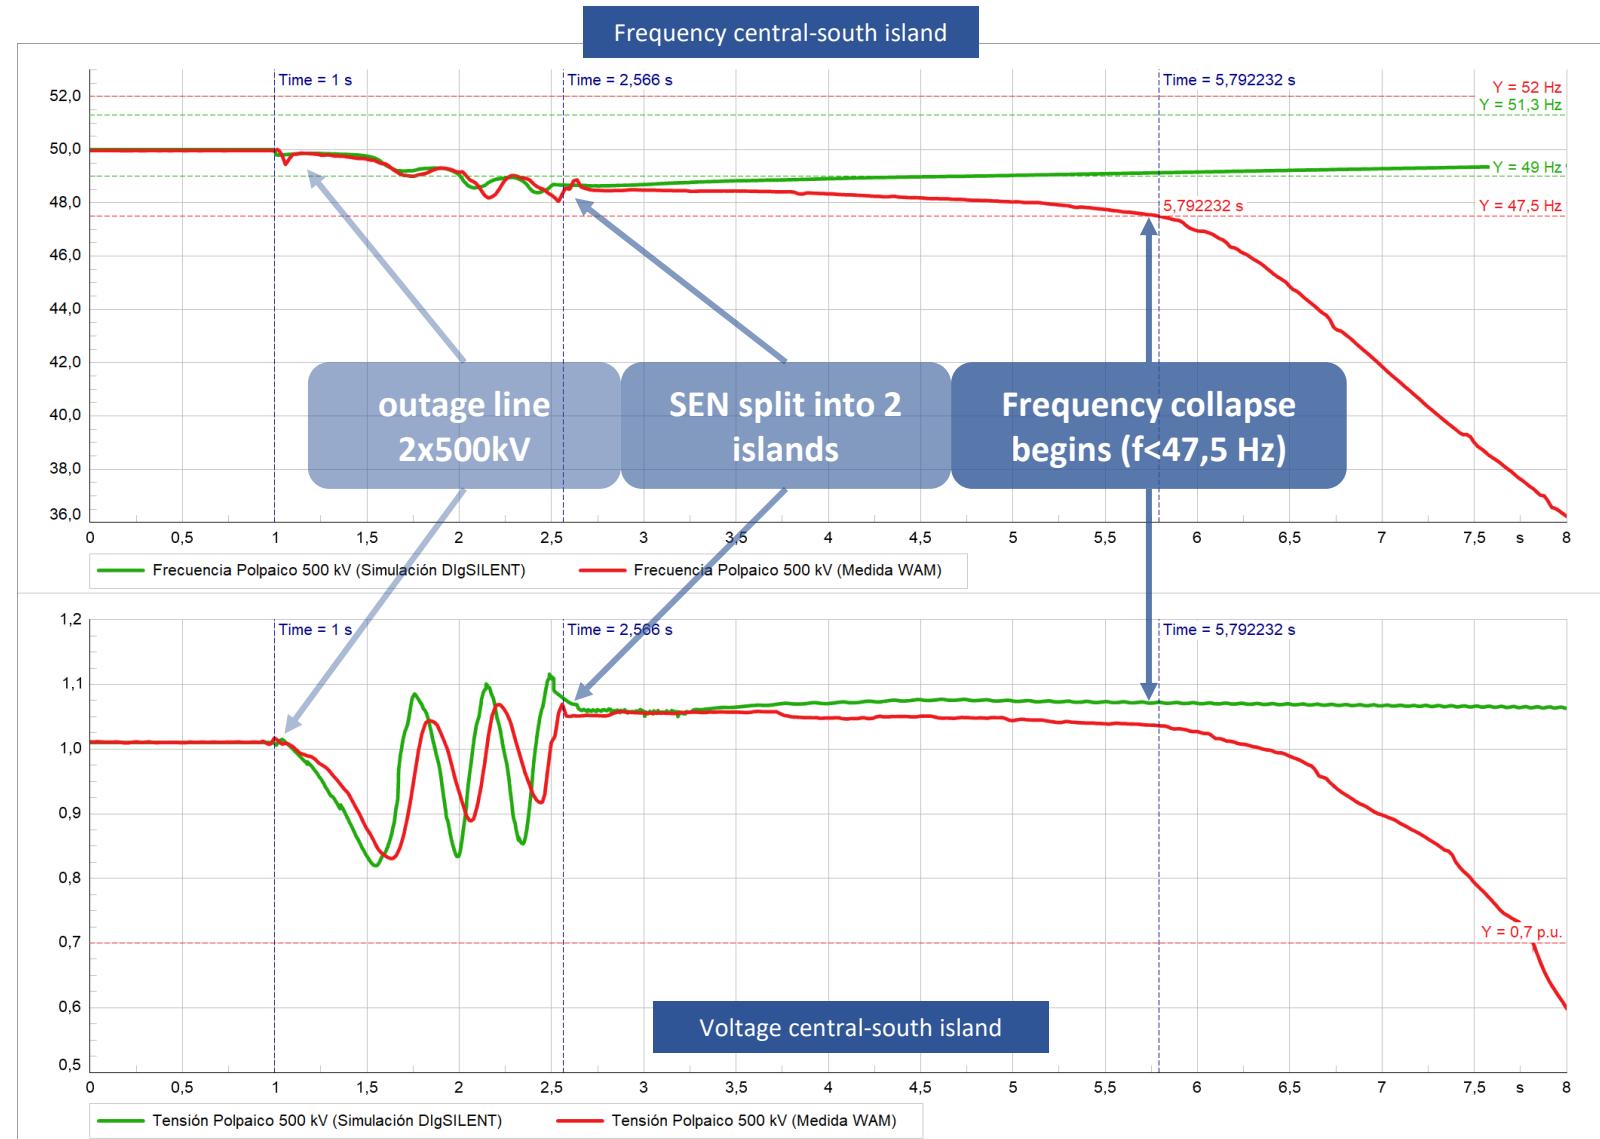
Real vs Expected Behavior of Central-South Island

Real behavior (PMUs – Red line)

- 1,450 MW generation disconnected earlier than expected.
- UFLS malfunctioned or misoperated due to DERs.

Expected behavior (Simulations – Green line)

- If all protections had correctly worked, frequency and voltage would have remained stable.
- The central-south island **should have remain stable**, avoiding the blackout.

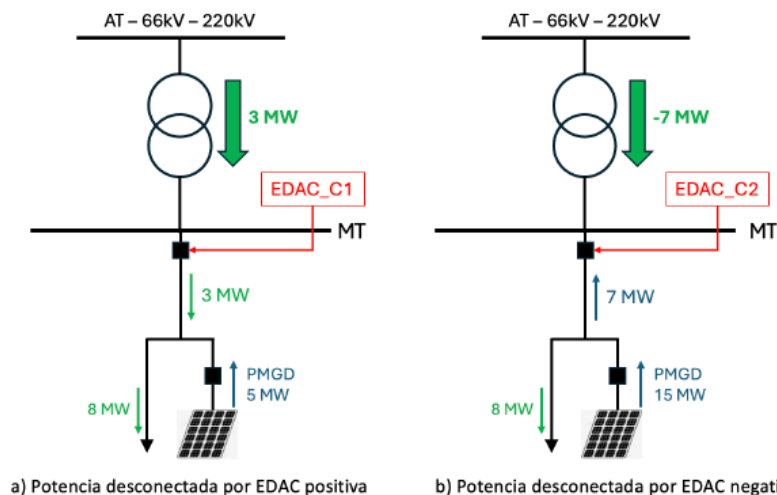
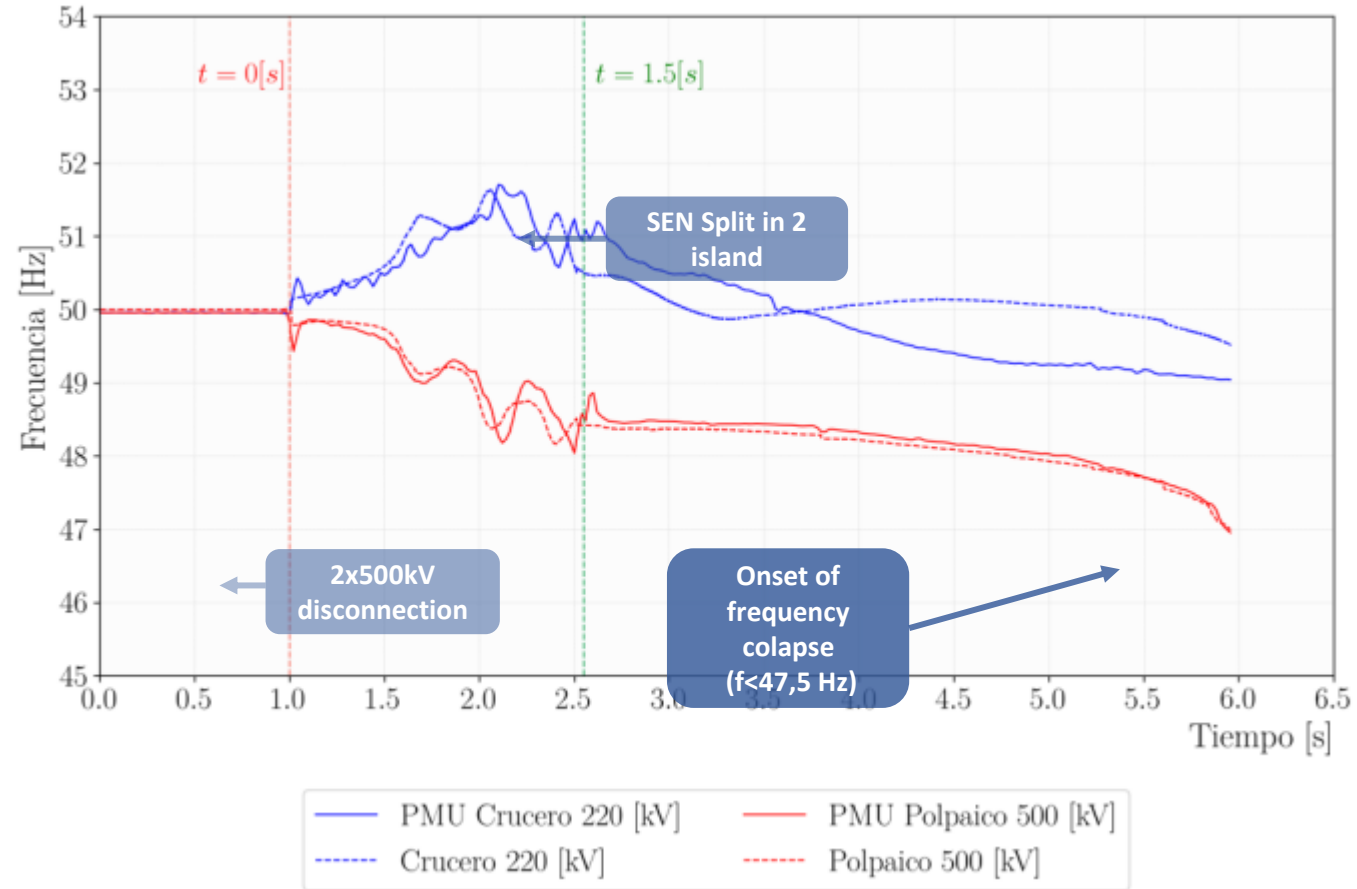
Simulations by Chilean Universities

- **Blue line:** simulated (dotted line) vs recorded (PMU) frequency response in the **northern island**.
- **Red line:** simulated (dotted line) vs recorded (PMU) frequency response in the **center-south island**.
- **Blackout could have been avoided** with compliance with the grid code by all generating units, and with **properly functioning UFLS schemes (with associated DER)**

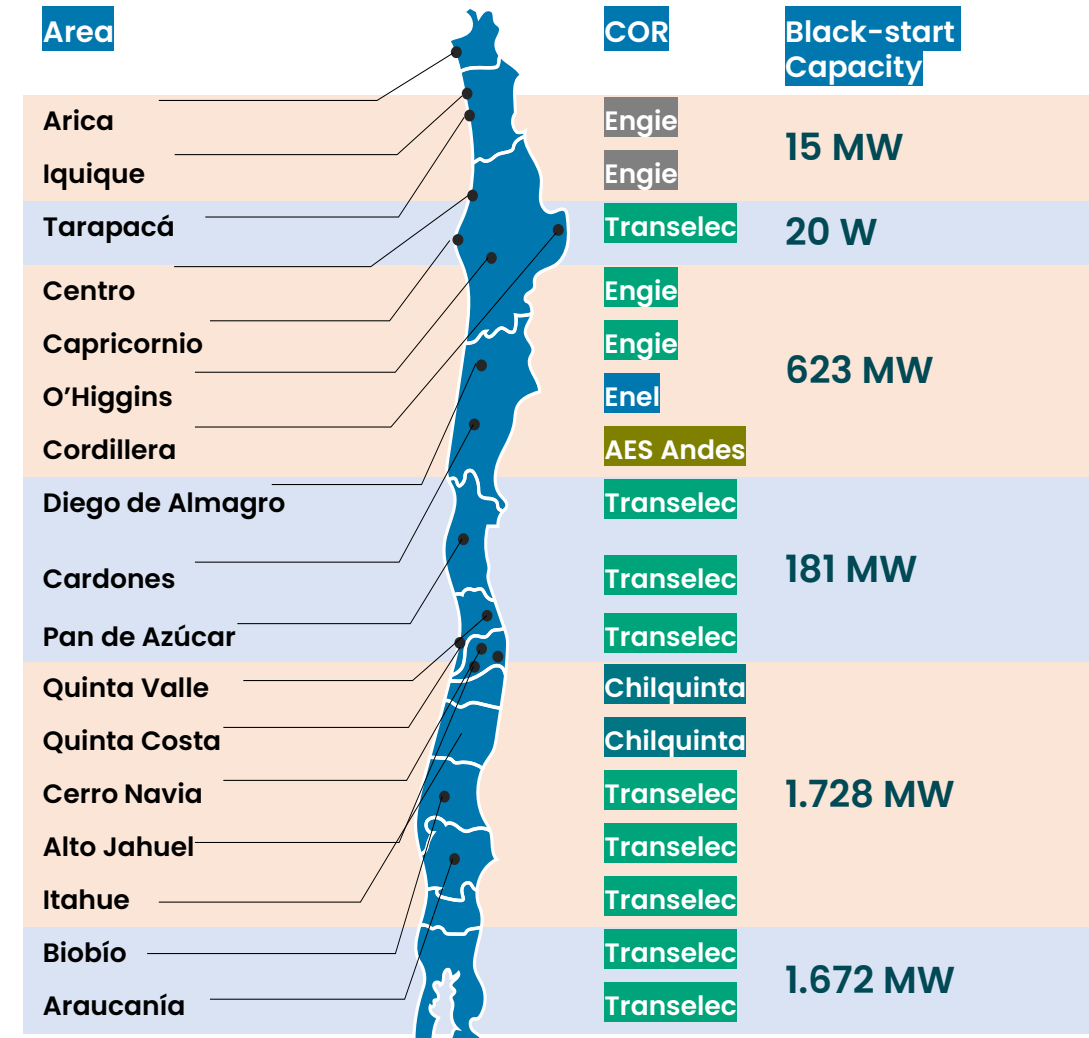
System recovery

- Several **black-start facilities failed to synchronize to the grid, delaying the recovery process.**
- Several **SCADA systems** in charge of the COR (Regional Restoration Operation Centers) function **failed, causing the loss of visibility and controllability** of the black-start situation and transmission facilities status.
- One of the largest transmission companies lost its SCADA for three hours, delaying the recovery process.
- **90% of regulated demand was restored in 9 hrs.** Total demand recovered within in 24 hrs.

- **Instruct** asset owners to correct generation settings that caused unexpected trips.
- **Conduct** technical inspections and normalize protection schemes, replacing failed comm modules.
- **Direct** DER plants to verify and adjust protection settings per grid code.
- **Request** UFLS data and normalization of DER configurations.
- **Submit** fault report and report all grid code non-compliances.

- **Instruct** to modify communication scheme design to meet independence and redundancy requirements.
- **Propose** regulatory updates for GFM/GFL inverter requirements and **new DER visibility and controllability standards.**
- **Initiate** technical audit of TO protection SCADA and communication systems.
- **Start** review of methodologies and resource adequacy for load-shedding, RAS, and system recovery plans.
