# Odessa Disturbance Events May 2021 & June 2022

Patrick Gravois  
Operations Engineer – Operations Analysis

ESIG Webinar  
November 3, 2022

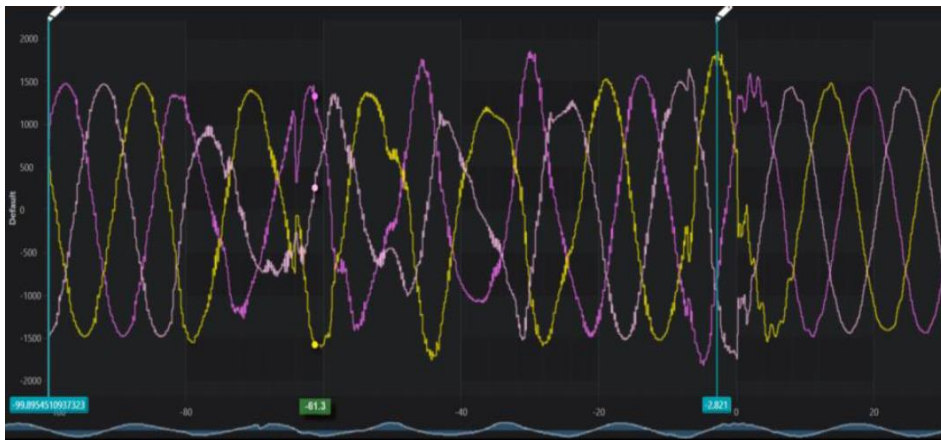
# AC Overvoltage – Inverter Level

- Two solar facilities – reductions of 205 MW and 64 MW
- POI high resolution data shows voltage within PRC-024-3 and ERCOT NOG voltage “no trip” curve (<1.2 pu)
- Inverter experiences spikes (instantaneous peak) above 1.3 pu at terminals
- OEM states overvoltage settings cannot be modified for any existing facilities due to inverter protection
- AC overvoltage tripping for this OEM will likely continue to occur in future
- Identified in nearly all solar PV disturbances analyzed by NERC
- Potential corrective action is to reduce k-factor of DVC within inverter to reduce reactive injection
- Both facilities performed PSCAD studies on reduced k-factor and saw improvement

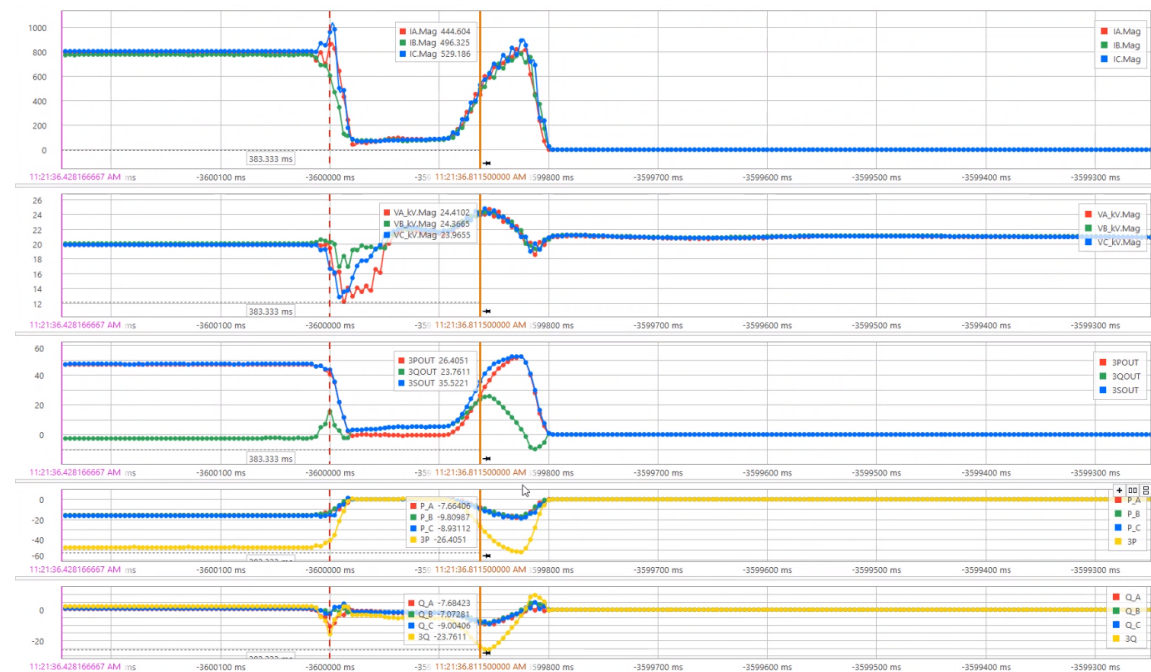
# AC Overvoltage – Feeder-Level

- Voltage driven high by reactive current injection after fault cleared and voltage recovered
- All feeder protection at one facility set to trip on instantaneous phase ac overvoltage
- Set at 1.2 pu – directly on PRC-024-3 and ERCOT NOG VRT curves
- Review team questioned need for this feeder-level protection
- Plant personnel unable to clarify what the voltage protection was protecting at the feeder level
- Plant has since disabled feeder level overvoltage protection – concern that inverter protection could trip for similar event

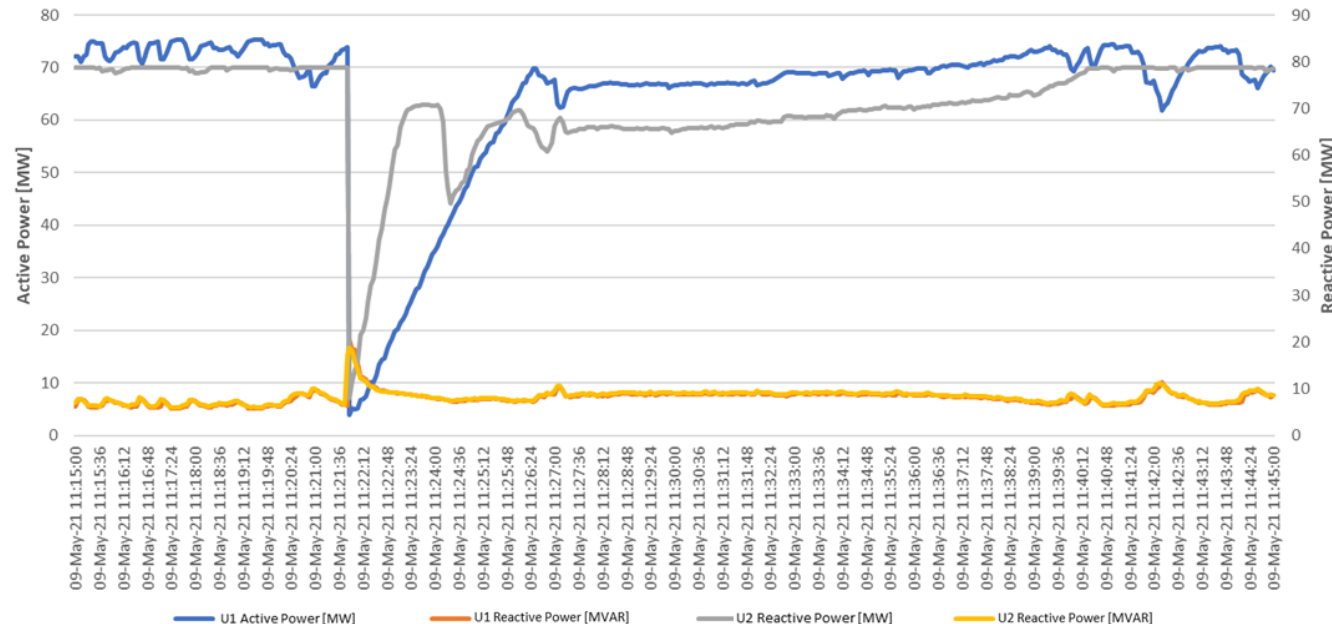
# Momentary Cessation

- Legacy inverters at one plant – momentary cessation below 0.9 pu voltage
- Inverters should recover to predisturbance output relatively quickly (<1 sec) when voltage recovers
- Plant-level controller interactions – slowed recovery to BA ramp rate limits
- Not appropriate use of these limits; negatively impacting system stability
- Not meeting recommended performance in NERC reliability guidelines
- Plant has replaced PPC since 2021 Odessa event to improve recovery time

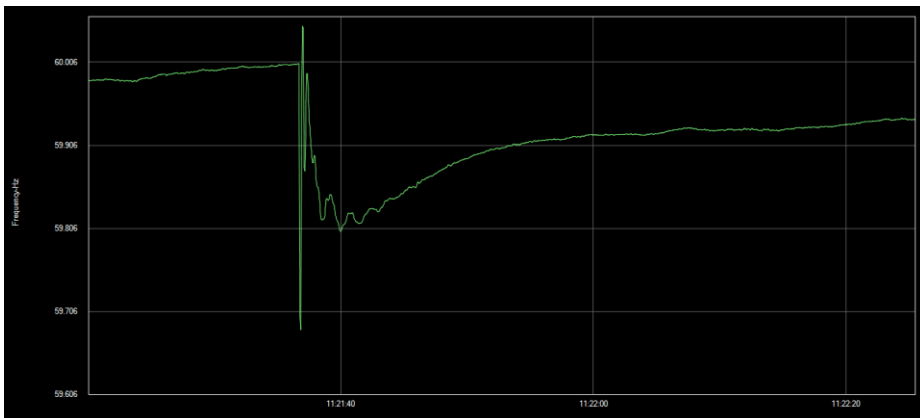
# Underfrequency – Inverter and Feeder

- Inverter-Level Underfrequency:
  - One facility had all inverters trip on “grid underfrequency” below 58.2 Hz
  - Grid frequency did not fall outside of the PRC-024-3 boundaries – low frequency of 59.8 Hz
  - Inverters likely erroneously tripped on a poorly measured or calculated frequency signal during fault conditions
  - Facility modified settings but not until after Odessa 2022

- One feeder-level relay operated on frequency below 57.5 Hz
- NERC followed up with relay OEM to perform root cause analysis
- Newer relay version used at this facility, set with very fast measurement window
- Relay OEM modifying adjustable window to eliminate problem – at least 5-cycle measurement window
- Facility has modified settings but not until after Odessa 2022

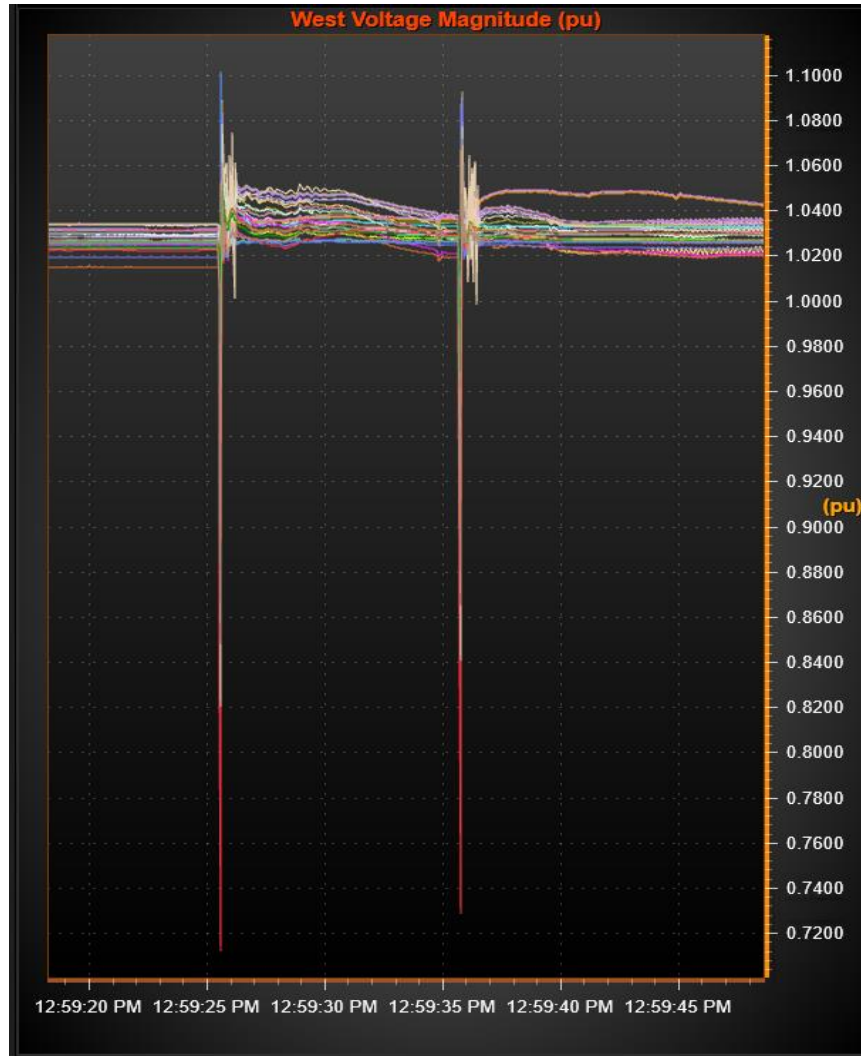
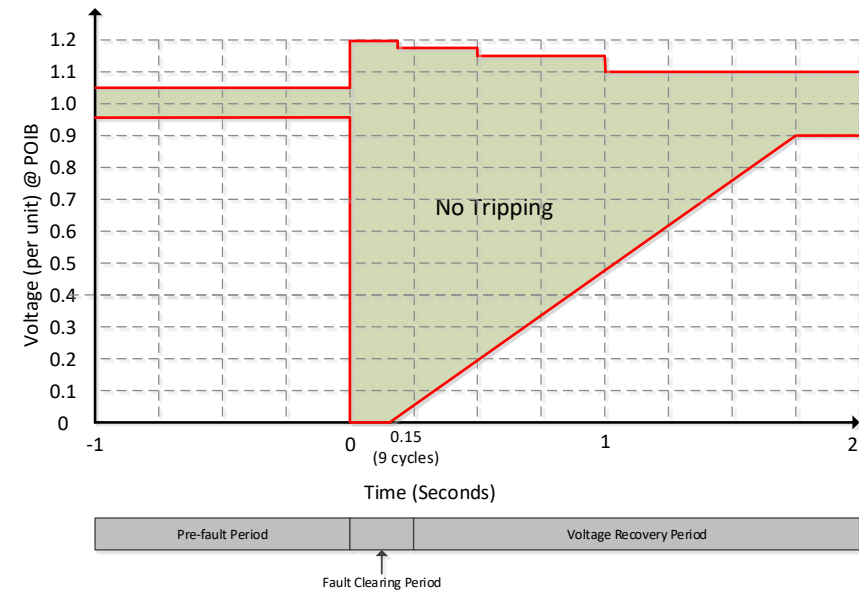
# Real Time PMU Voltages

- ERCOT has ~200 PMUs streaming real time data
- Lowest recorded voltage of 0.714pu from PMU in Odessa area on 345 kV line
- Highest recorded voltage of 1.102pu from PMU in Del Rio area on 138 kV line
- Fault cleared in ~3 cycles
- Attempted reclose ~10 seconds later
- Within VRT “No Tripping” zone in NOG 2.9.1

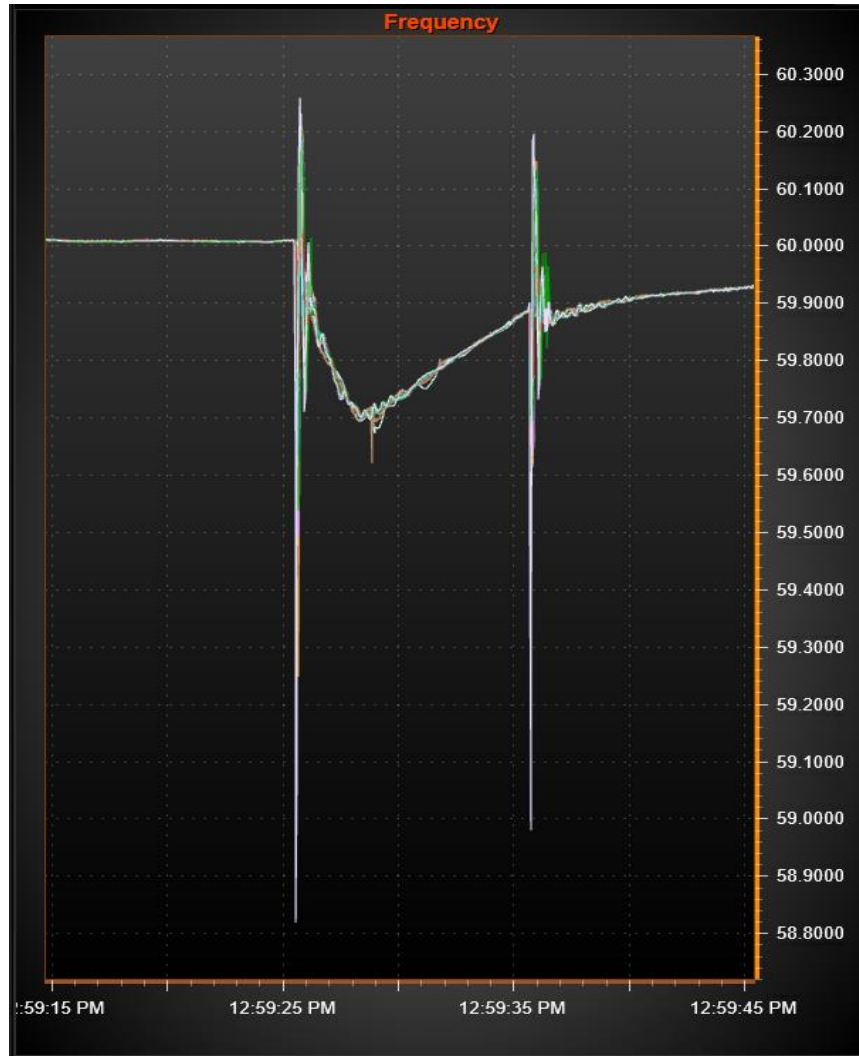
# Real Time PMU Frequency

- Most PMUs lowest freq. of 59.7 Hz after loss of generation
- Single PMU near Laredo had lowest freq. of 59.62 Hz
- Couple other PMUs in South Texas dipped below 59.7 Hz
- Local frequencies during fault conditions measured as low 58.83 Hz and high as 60.26 Hz in Far West Texas
- Protection settings should measure frequencies over >5 cycles to prevent unnecessary tripping

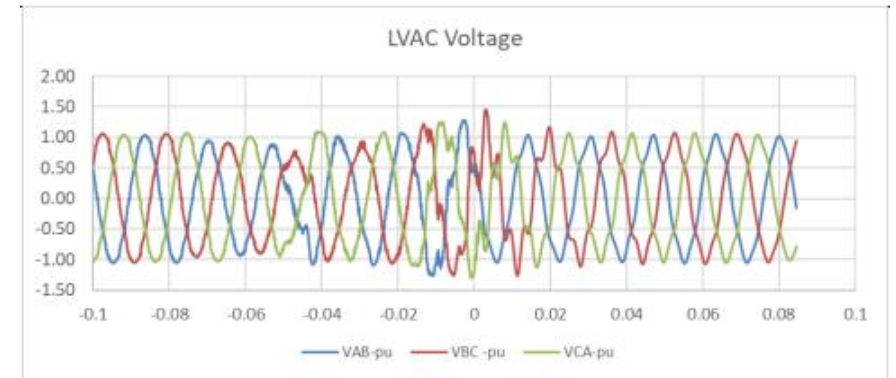
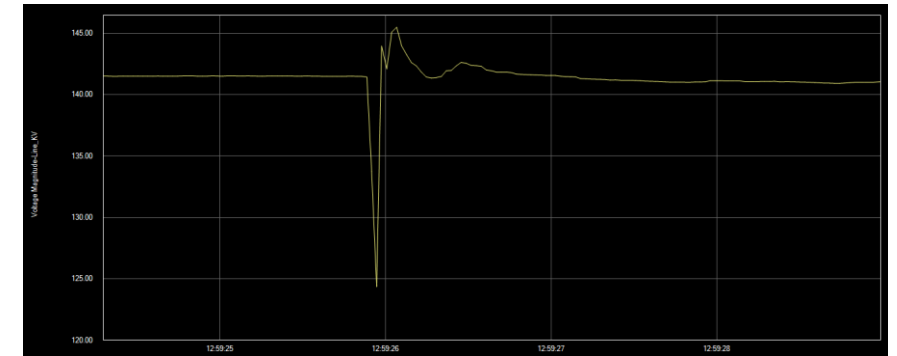
# AC Overvoltage – Inverter Terminals

- Had feeder breaker trip on underfrequency during 2021 Odessa event
- All inverters tripped on Instant AC Overvoltage in which inverter trip occurs in 1-3 ms when voltage exceeds 1.25pu
- Inverter terminal voltage reached > 1.3pu during event, but high side of GSU only reached 1.056 pu per PMU data provided by RE – likely caused by reactive injection once fault has cleared
- Plant had two feeder breakers trip on underfrequency < 57.5 Hz; have adjusted breaker underfrequency settings since event
- OEM has identified potential solutions – increasing fast overvoltage protection to 1.4 pu and reducing k-factor to reduce reactive injection causing high voltage at inverter terminals

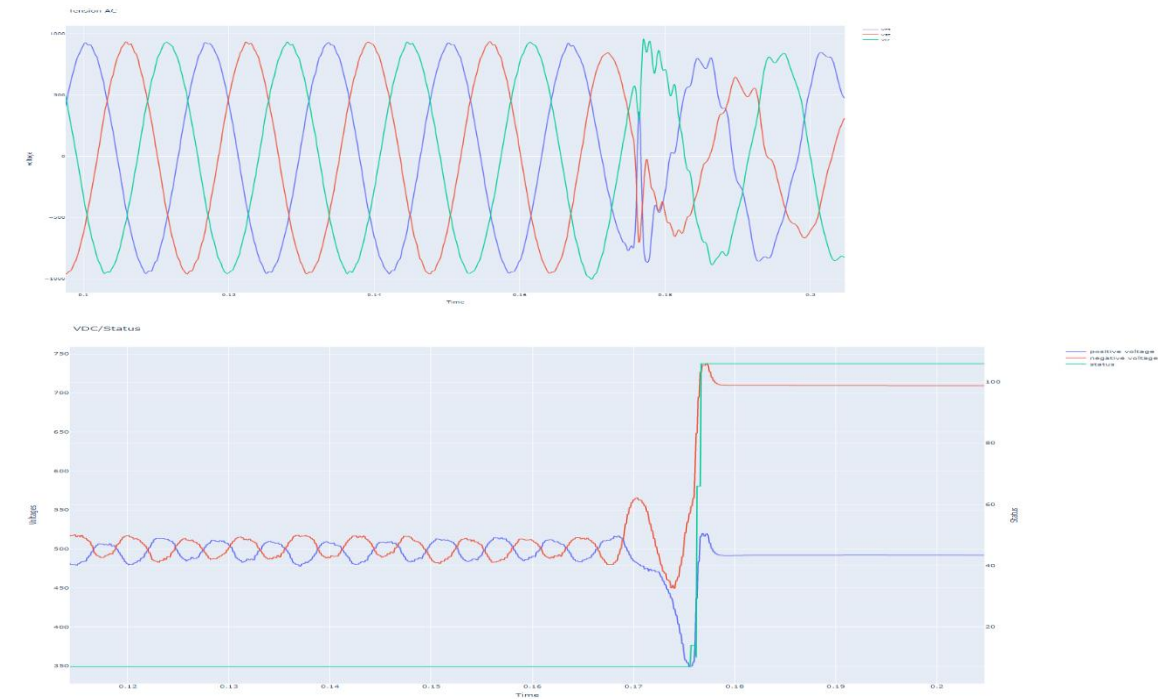
# Vdc Bus Unbalance

- **2 plants with OEM2 inverters (neither plant involved in 2021 Odessa event)**
  - Fault Code for Vdc Unbalance occurs when DC-side positive and negative bus voltage differ by  $> 100$  V (minor) or  $> 200$  V (major) for 1 ms
  - AC voltage phase became unbalanced faster than controls could regulate DC-side due to disturbance
  - Plants and OEM claim protection operated correctly and required for equipment protection – potential DC short
  - Issue seen in previous events and OEM was already working on fix
  - Software update currently available to improve DC regulation response time and ride-through capabilities
  - One plant has already implemented software upgrade; Second plant scheduled in November

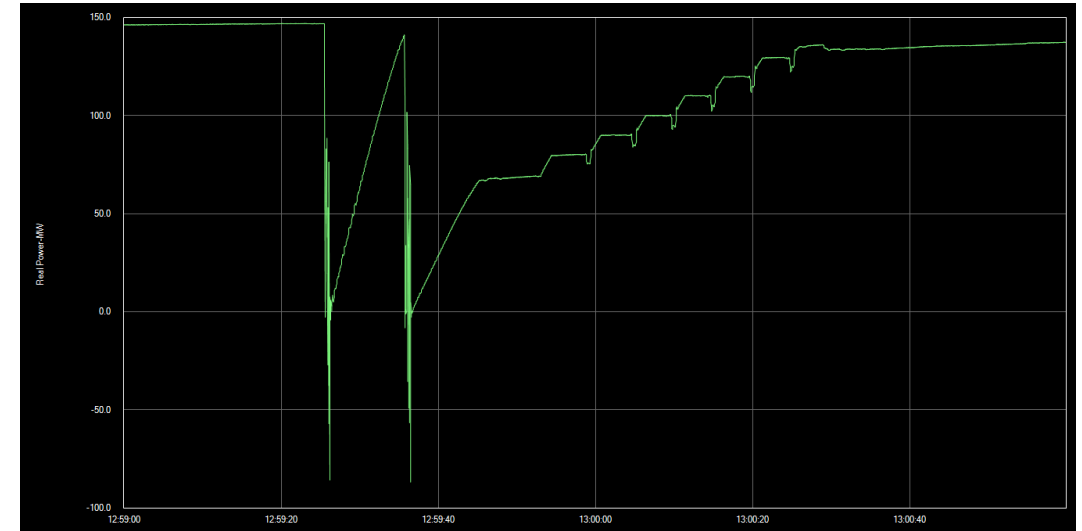
# Slow Ramp After LVRT

- **1 plant with OEM2 inverters**
  - Provides 100% reactive current during LVRT and did not recover quickly (~10 sec) upon fault clearing
  - Issue identified during Odessa 2021 event analysis but primary cause during 2021 event was feeder breaker tripping on underfrequency (since disabled)
  - Plant has adjusting settings to:
    - Change LVRT/HVRT mode to provide consistent active power as well as required reactive power
    - Change fast overvoltage protection trip settings to 1.35pu with 0.5 sec delay
  - LVRT mode disabled during 2022 event – caused slow response due to PPC interactions
  - LVRT now enabled and all inverter setting changes complete
  - PSCAD modeling required to determine cause of oscillations

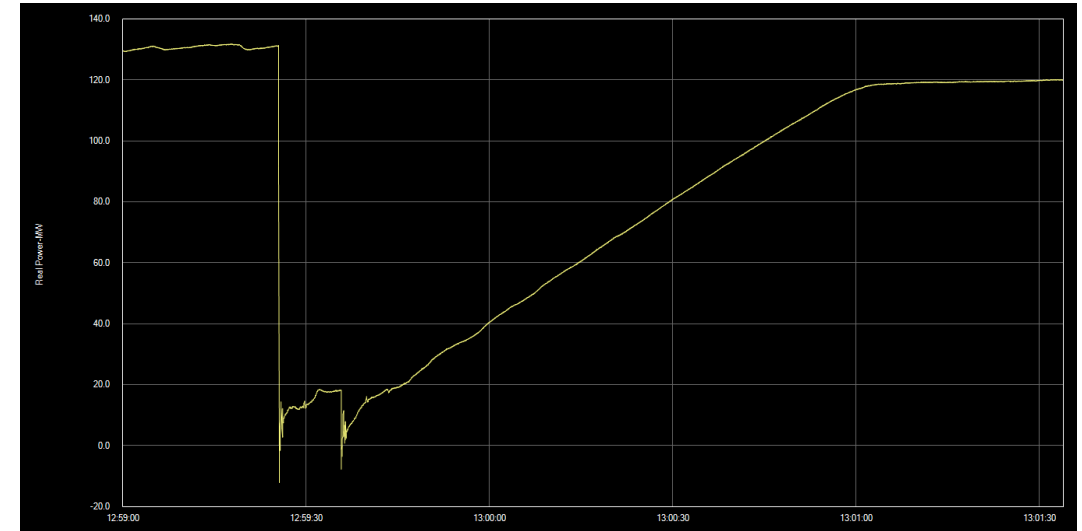
# Momentary Cessation

- Previously thought momentary cessation could not be disabled but discovered it was disabled during 2022 event
- Inverters reduced output due to loss of auxiliary power during 2022 event
- Legacy inverters with limiting logging capabilities – difficult to identify corrective actions to improve response
- Unclear whether voltage drop or phase jump caused initial active power loss
- One potential corrective action is to install UPS for each inverter – unclear if this would allow inverters to ride-through large phase jump
- Momentary cessation reenabled to allow quicker return after fault clearing – cannot provide reactive
- Potentially may not be able to meet current VRT requirements with current inverters
