# Blackout in Spain and Portugal on 28 April 2025

Expert Panel Factual Report >> 27 October 2025 >> ESIG workshop

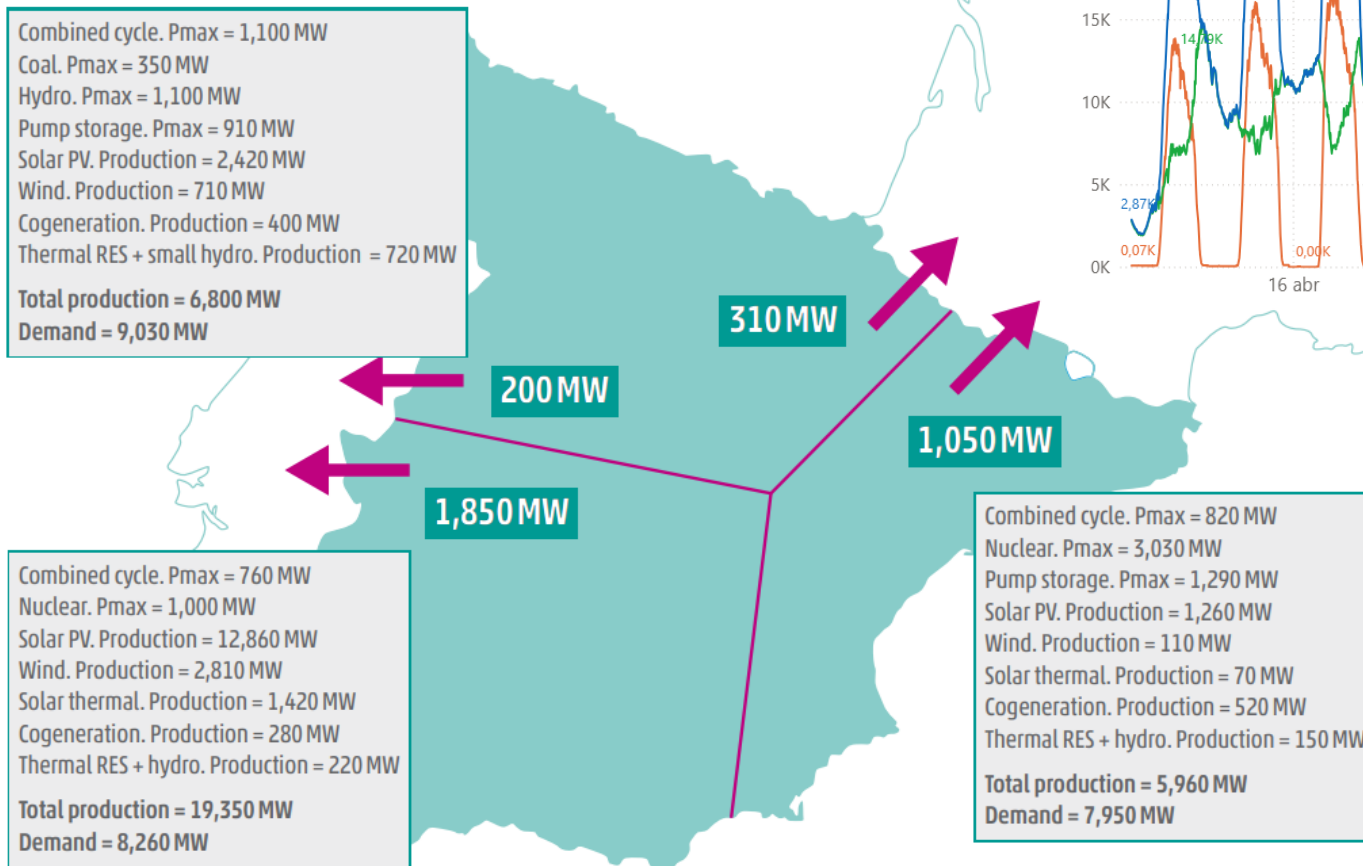
Figure: Geographic distribution of generation in Spain at 12:32 CEST

**High concentration of renewables in South-West Spain at noon CEST.**

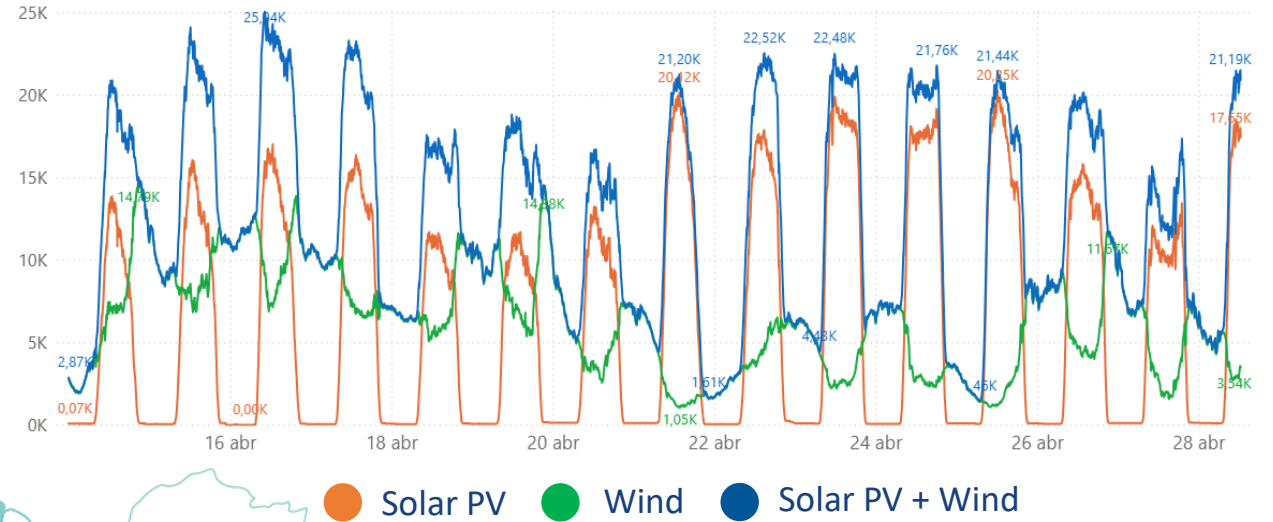
Figure: PV and wind production in Spain in previous days

Renewable infeed followed patterns usually observed on a spring day in Spain.

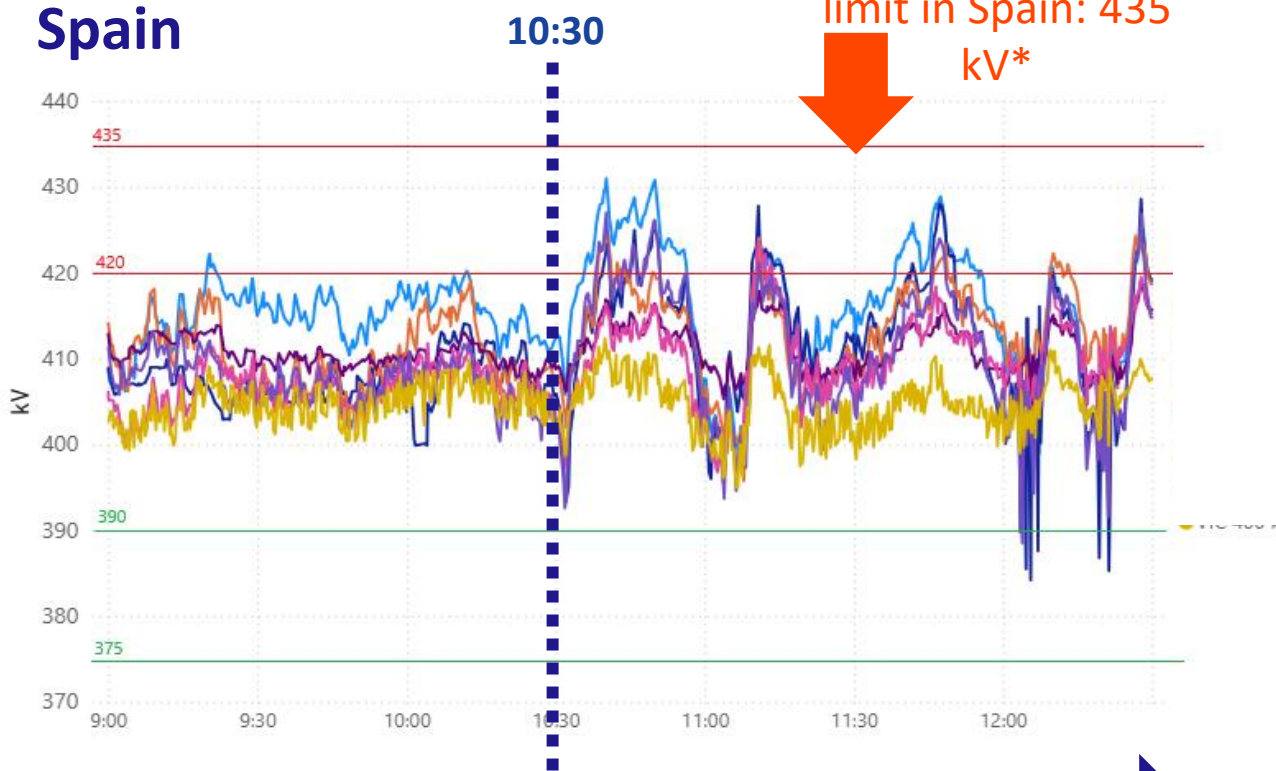
# First voltage fluctuations observed in Spain

Within the normal range of operations

\* These values may occur eventually at the 400 kV level (confirmed by CNMC, Spanish regulator)

First significant variations of the voltage from 10:30 CEST
