Chilean Grid Blackout of February 2025: Causes and Lessons

ESIG 2025 Fall Technical Workshop

Coordinador Eléctrico Nacional (CEN) - Chile

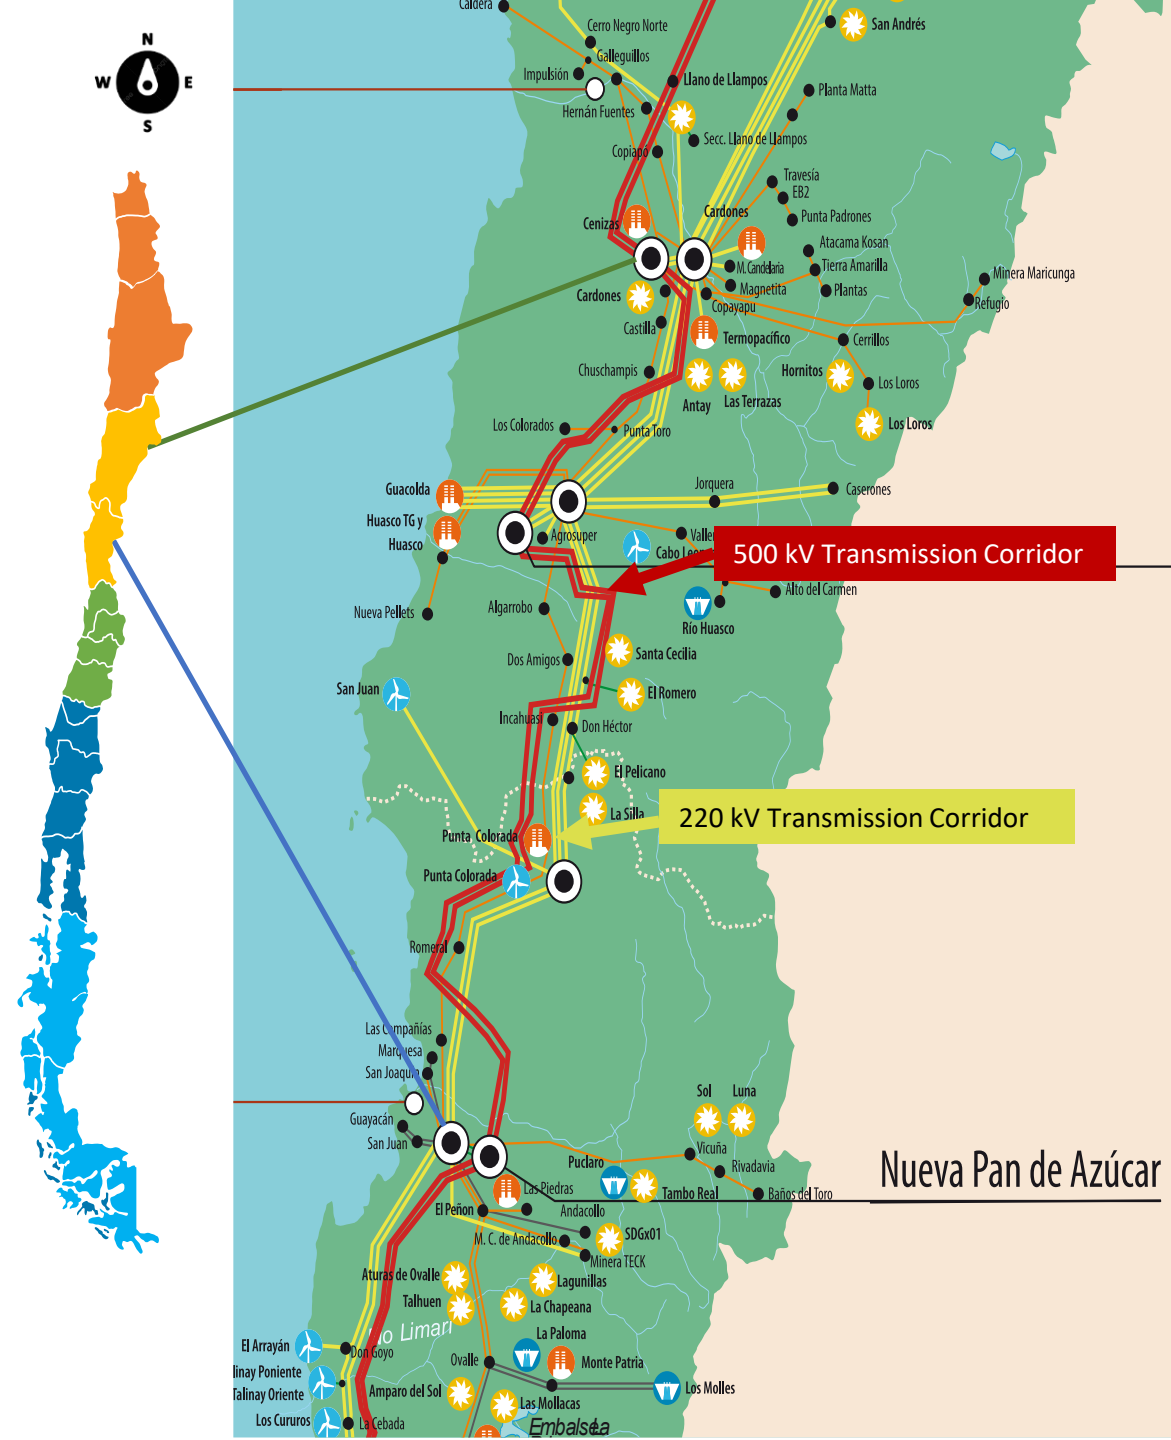
The Electric System operated in an interconnected and stable condition.

11.657 MW

1,800 MW N→S 2x500 kV NMA- NPA line. 90% of the line's capacity.

The northern part mainly transmitted solar and wind (IBR-GFL).

The southern region relied on energy from the north, local solar and wind, hydro, thermal power, and DER.

The system operated with N-1 safety criteria.

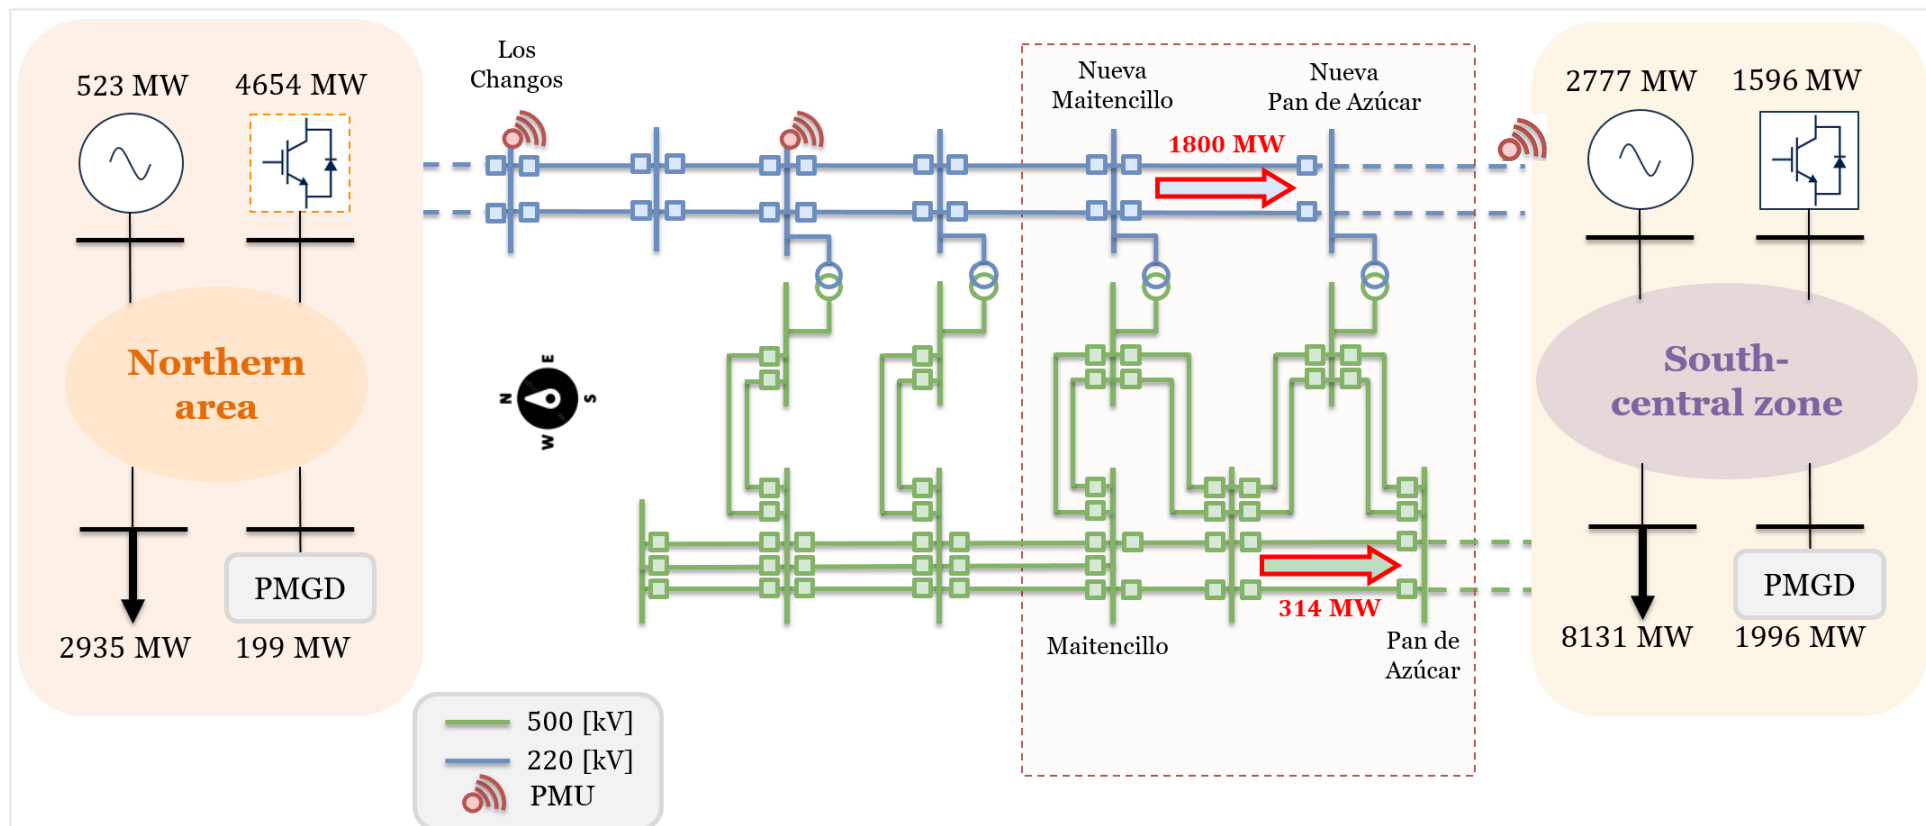
The situation before the blackout

Generation: 11.7 GW
VRE share: 72 %
Total N-S Power Flow: 2,114 MW

The Electric System operated in an interconnected and stable condition.
