# Odessa Disturbance Events May 2021 & June 2022

Patrick Gravois  
Operations Engineer – Operations Analysis

ESIG Webinar  
November 3, 2022

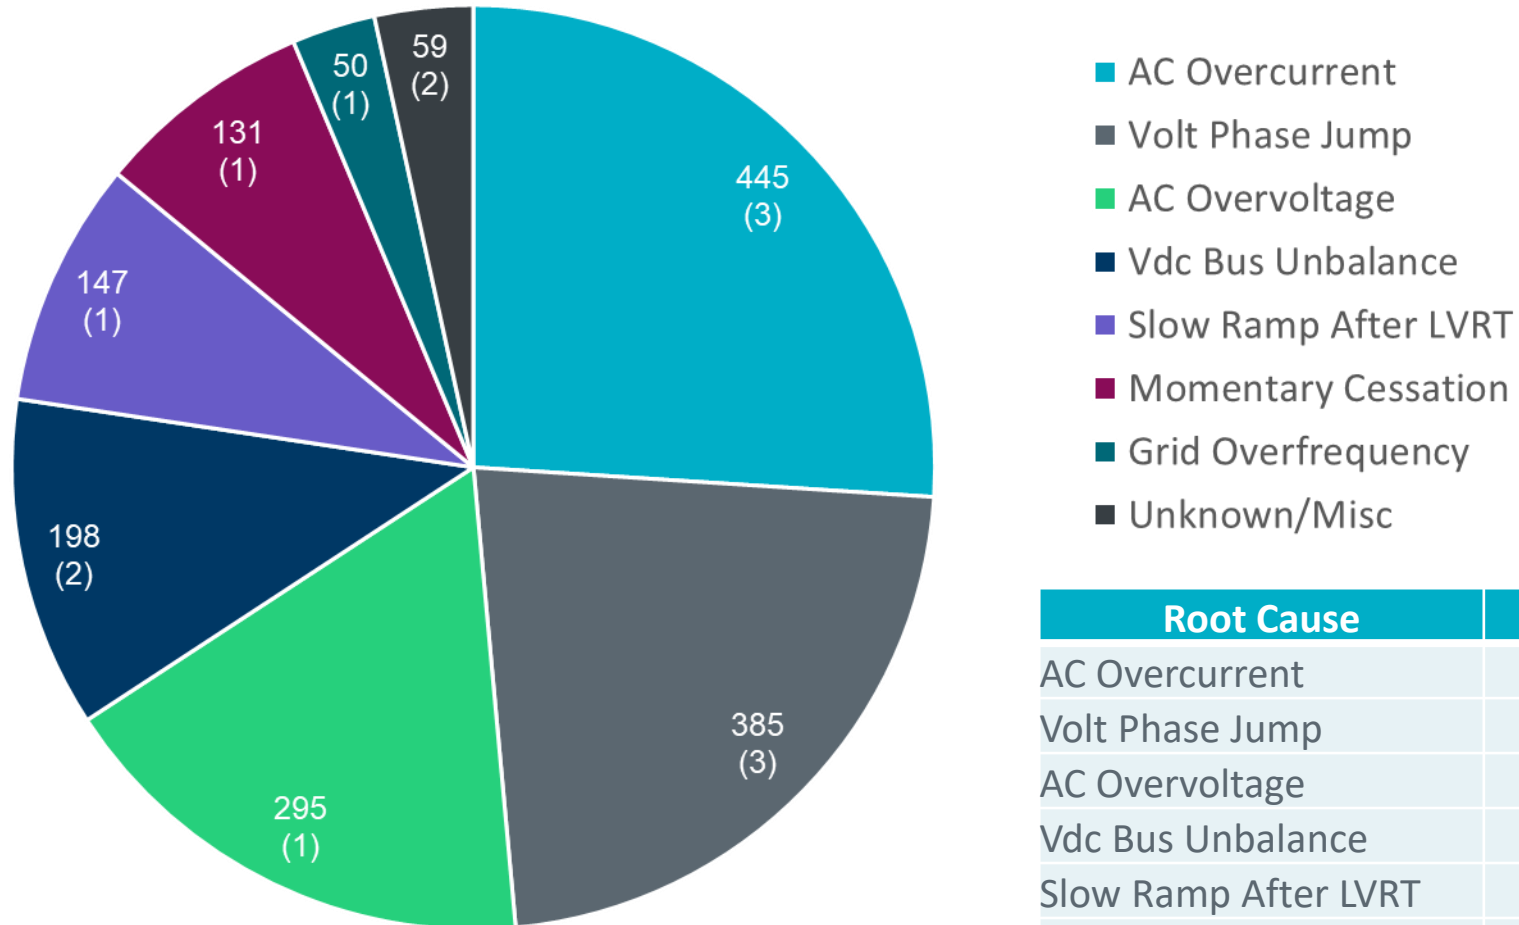
MW Loss by Root Cause

- **2 plants with OEM1 inverters (259 and 176 MW loss)**
  - Both plants in commissioning during 2021 Odessa
  - All inverters tripped on either AC Overcurrent Low (140% of rated current) or High (150% of rated current)
  - Overcurrent caused by distorted voltages and instantaneous current spikes during fault conditions
  - Protection prevents damage to insulated-gate bipolar transistors within inverter – cannot be increased
  - OEM developed and currently testing potential upgrade to prevent overcurrent during this type of event
- **1 plant with OEM3 inverters (10 MW loss)**
  - 7 of 79 inverters tripped – OEM out of business and unable to provide analysis/corrective actions

- **3 plants with OEM1 inverters for combined loss of 385 MW**
  - Plants had all inverters trip on Fault Code 221: Volt Phase Jump – occurs when expected phase angle deviates > 15 degrees
  - OEM confirmed it is not needed for inverter protection
  - OEM recommends either extending threshold to 35 degrees or disabling protection altogether
  - Up to GO to choose and authorize OEM to extend threshold or disable setting
  - Already extended or disabled at 2 plants; 3<sup>rd</sup> plant will be extending threshold
  - 2 plants tripped on inverter AC overvoltage and 1 plant tripped on PLL Loss of Synchronism in Odessa 2021

- Had feeder breaker trip on underfrequency during 2021 Odessa event
- All inverters tripped on Instant AC Overvoltage in which inverter trip occurs in 1-3 ms when voltage exceeds 1.25pu
- Inverter terminal voltage reached > 1.3pu during event, but high side of GSU only reached 1.056 pu per PMU data provided by RE – likely caused by reactive injection once fault has cleared
- Plant had two feeder breakers trip on underfrequency < 57.5 Hz; have adjusted breaker underfrequency settings since event
- OEM has identified potential solutions – increasing fast overvoltage protection to 1.4 pu and reducing k-factor to reduce reactive injection causing high voltage at inverter terminals

- **1 plant with OEM2 inverters**
  - Provides 100% reactive current during LVRT and did not recover quickly (~10 sec) upon fault clearing
  - Issue identified during Odessa 2021 event analysis but primary cause during 2021 event was feeder breaker tripping on underfrequency (since disabled)
  - Plant has adjusting settings to:
    - Change LVRT/HVRT mode to provide consistent active power as well as required reactive power
    - Change fast overvoltage protection trip settings to 1.35pu with 0.5 sec delay
  - LVRT mode disabled during 2022 event – caused slow response due to PPC interactions
  - LVRT now enabled and all inverter setting changes complete
  - PSCAD modeling required to determine cause of oscillations
